**2007
Environmental & Natural
Resources Conference**

Plum Brook Ordnance Works

PRRWP Lime Treatment Pilot Study

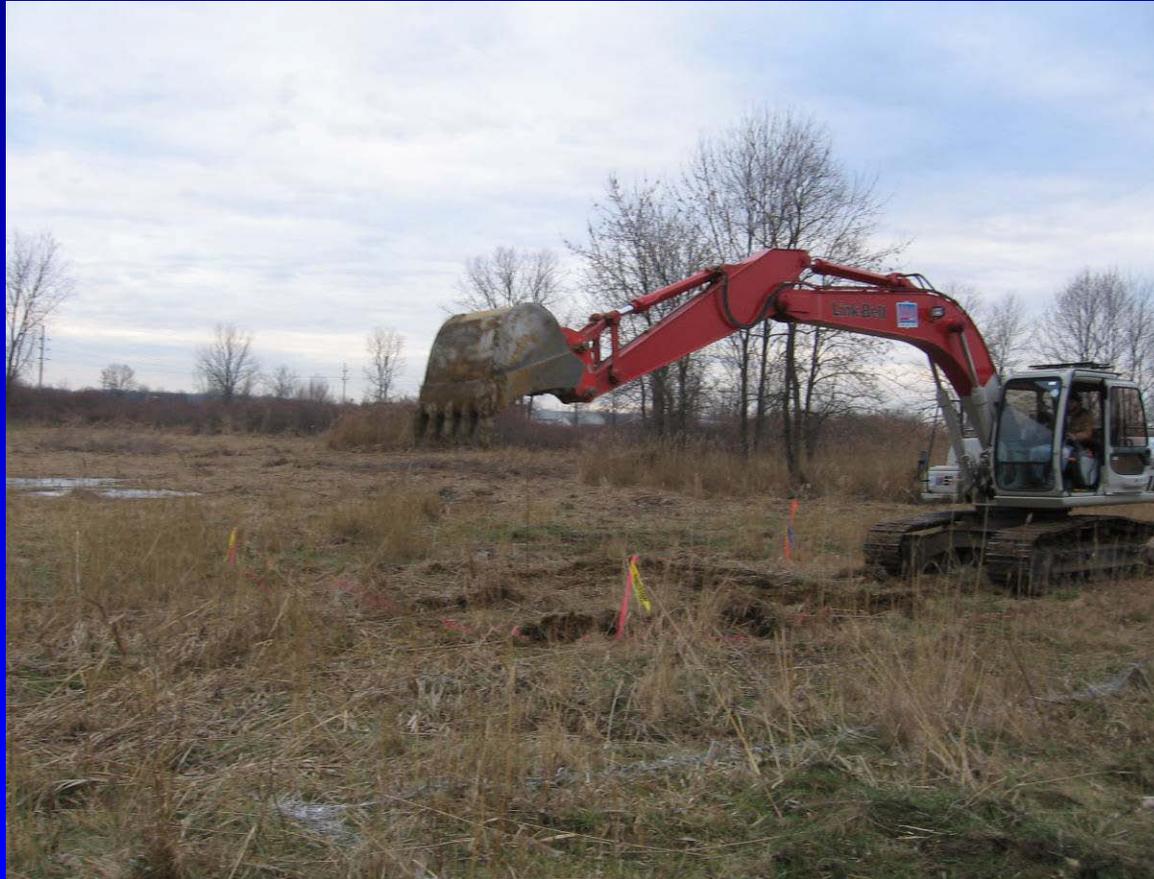
Initial Site Activities

- The basic approach was to excavate soil in the area of known contamination.
- The area of the excavation for the pilot study was approximately 20' x 20' x 8'.

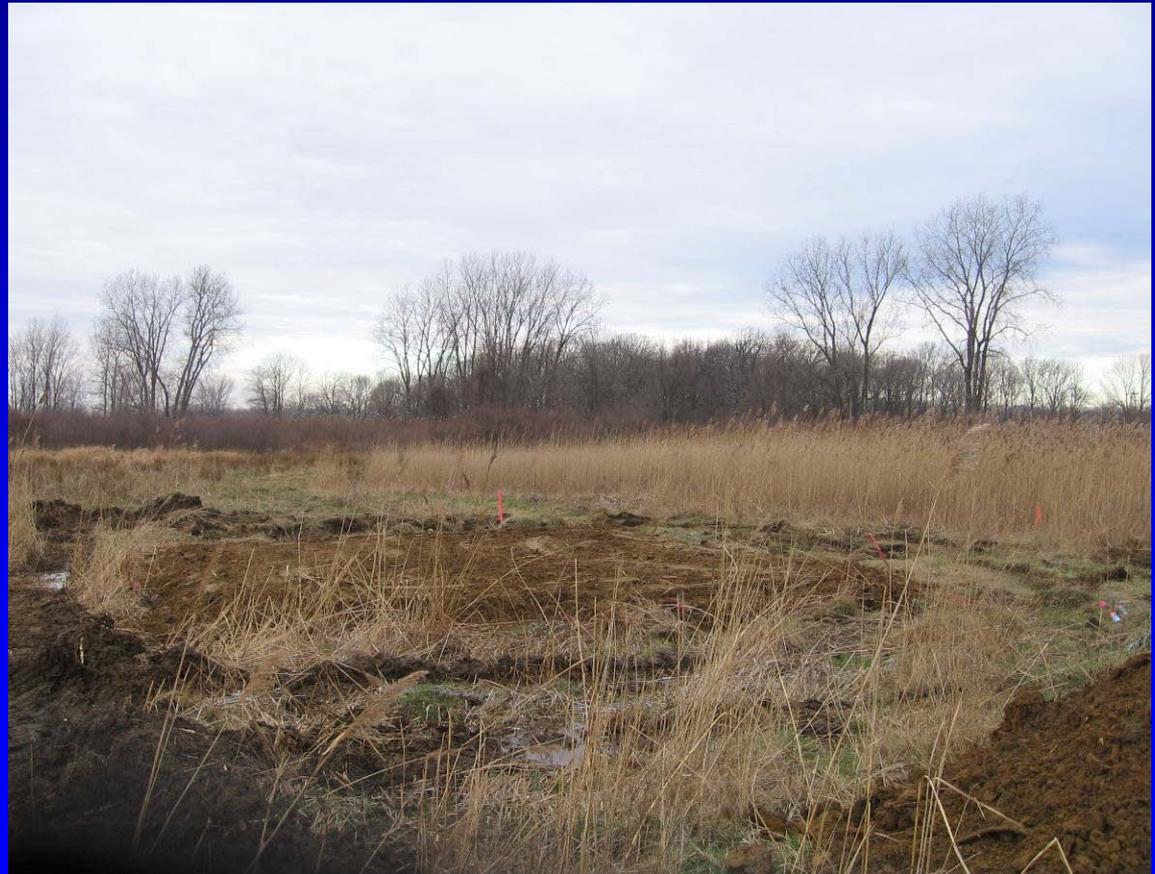
Treatment Pile Placement

- The excavated soil was placed into eight piles within the known area of contamination.
- The piles were approximately 20' x 20' x 1'.
- The piles were designated as numbers 1 to 8.

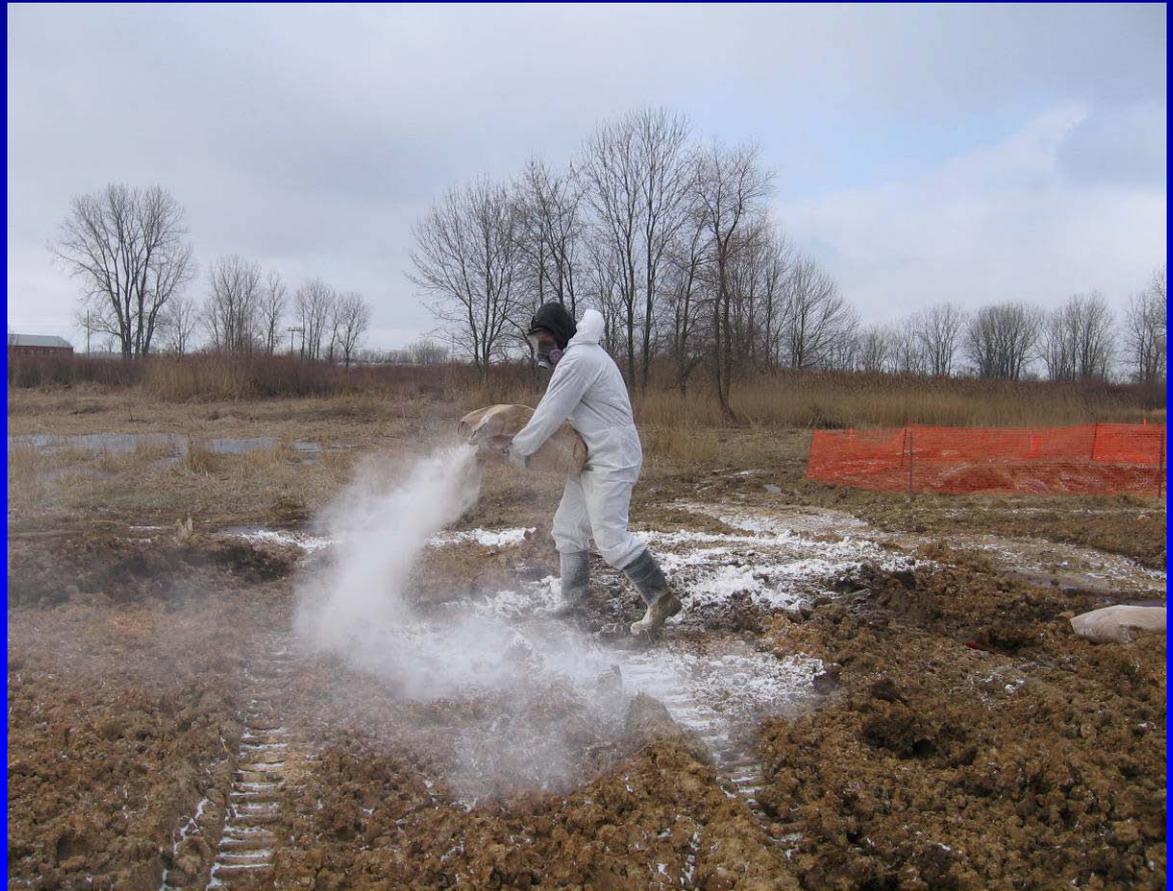
Lime application

- Application rate was 250 pounds per treatment.
- Piles 1 & 7 were control piles (no lime added during pilot study).
- Piles 2 & 8 were “weekly treatment piles”.
- Piles 3 through 6 were “daily treatment piles”.

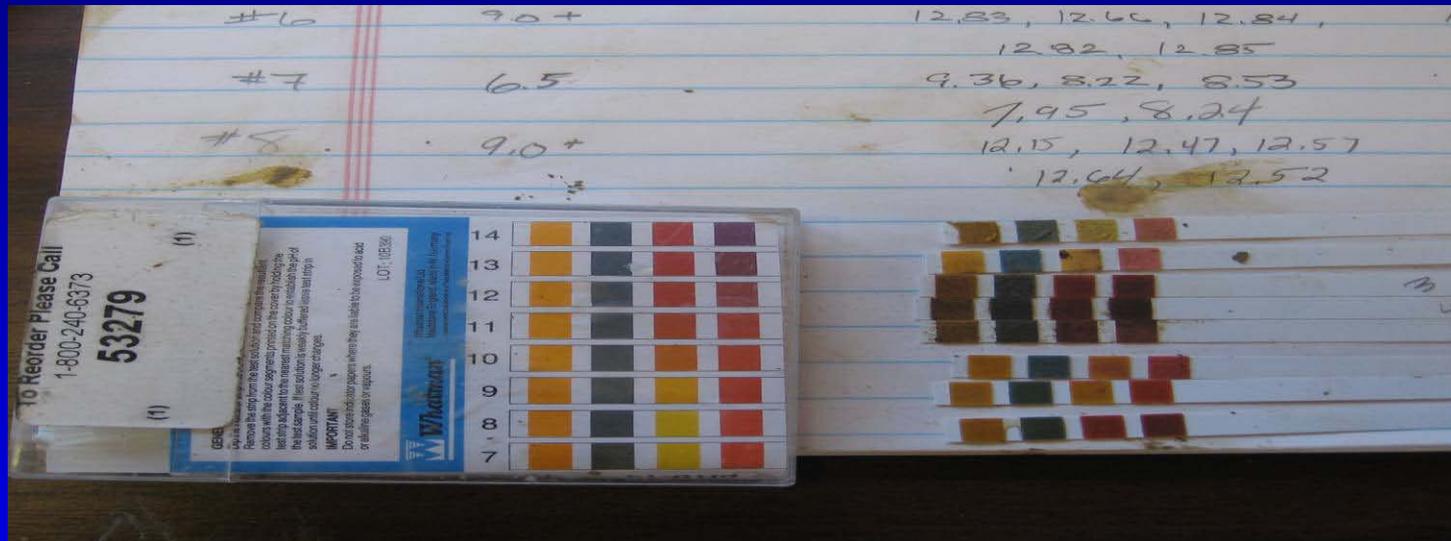
pH Monitoring

- The pH was measured every day using 3 different methods which provided inexpensive Quality Control.
Exstik Meter Garden Meter pH Paper
- Based on previous studies, the target pH for this study was 11 or above.

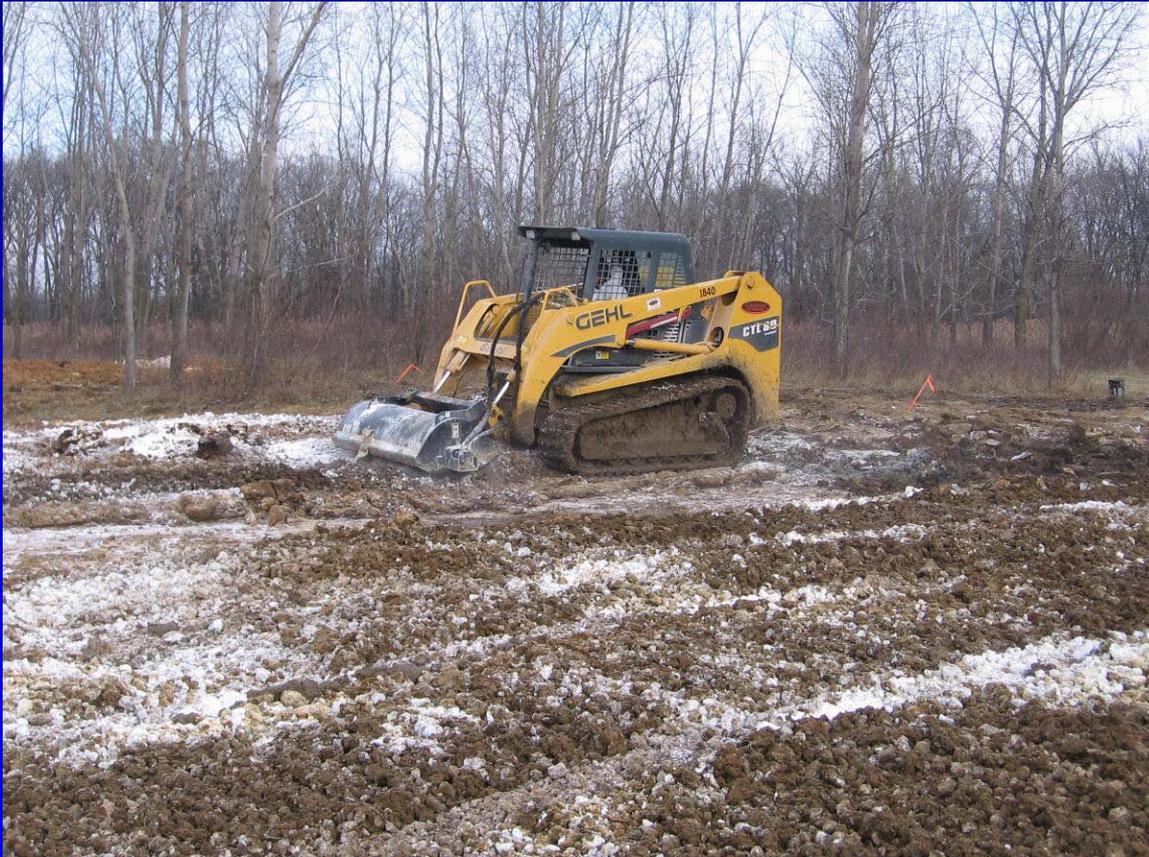
Soil and Lime Mixing

- **Mixing was accomplished using a skid steer mounted tiller.**
- **This ensured a thorough mixing of lime for the entire pile depth.**
- **All piles were tilled daily regardless of lime application.**

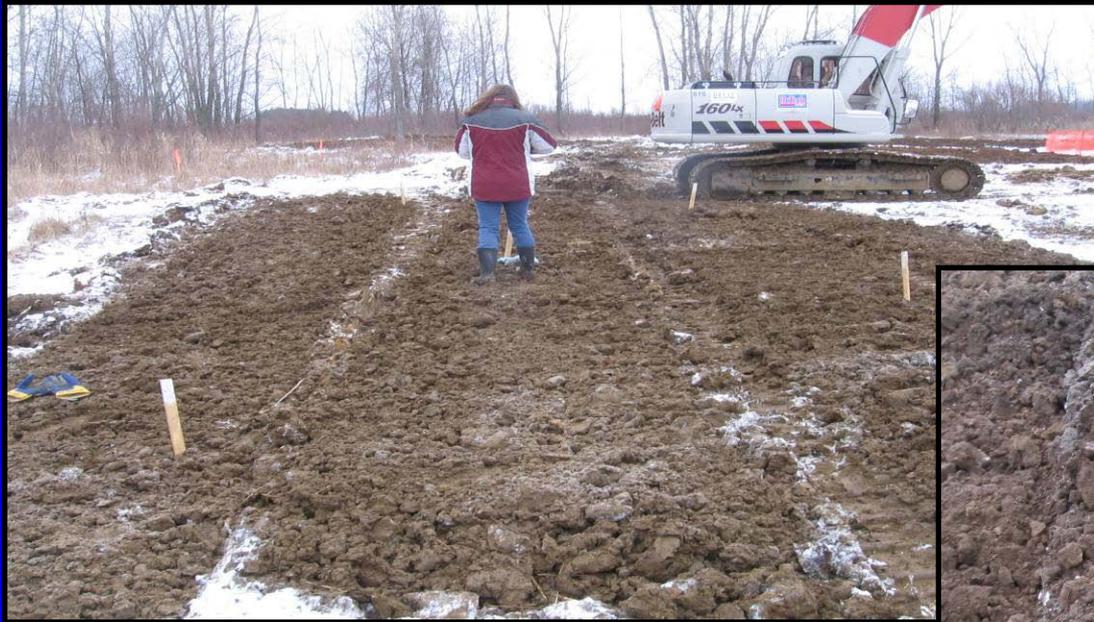
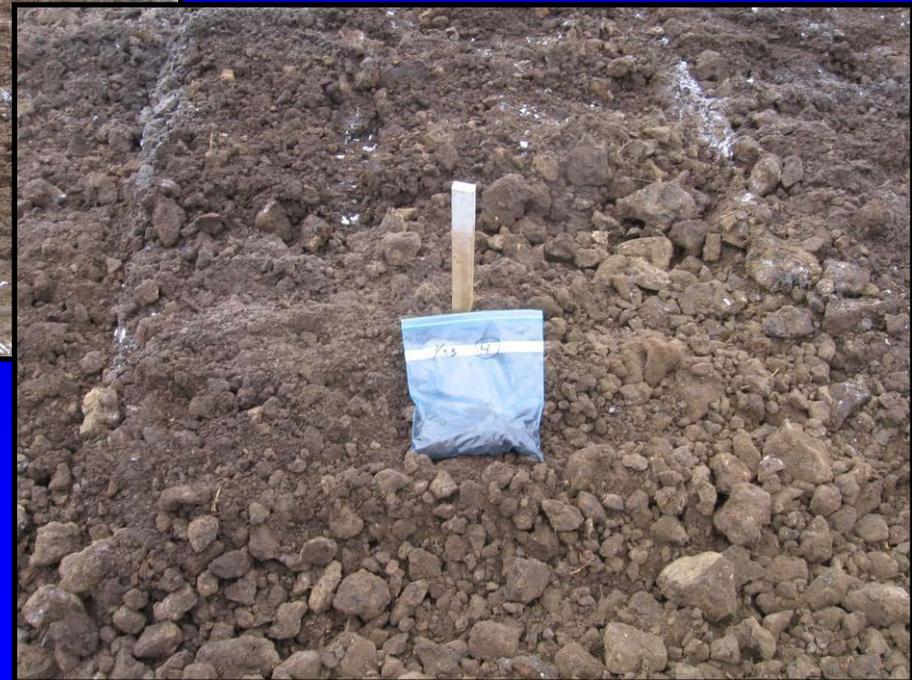
Soil Sampling & Analysis

Composite samples
were collected from
each pile weekly.

Samples were submitted for
laboratory analysis of pH and
Semi-volatiles using EPA
Method 8330.

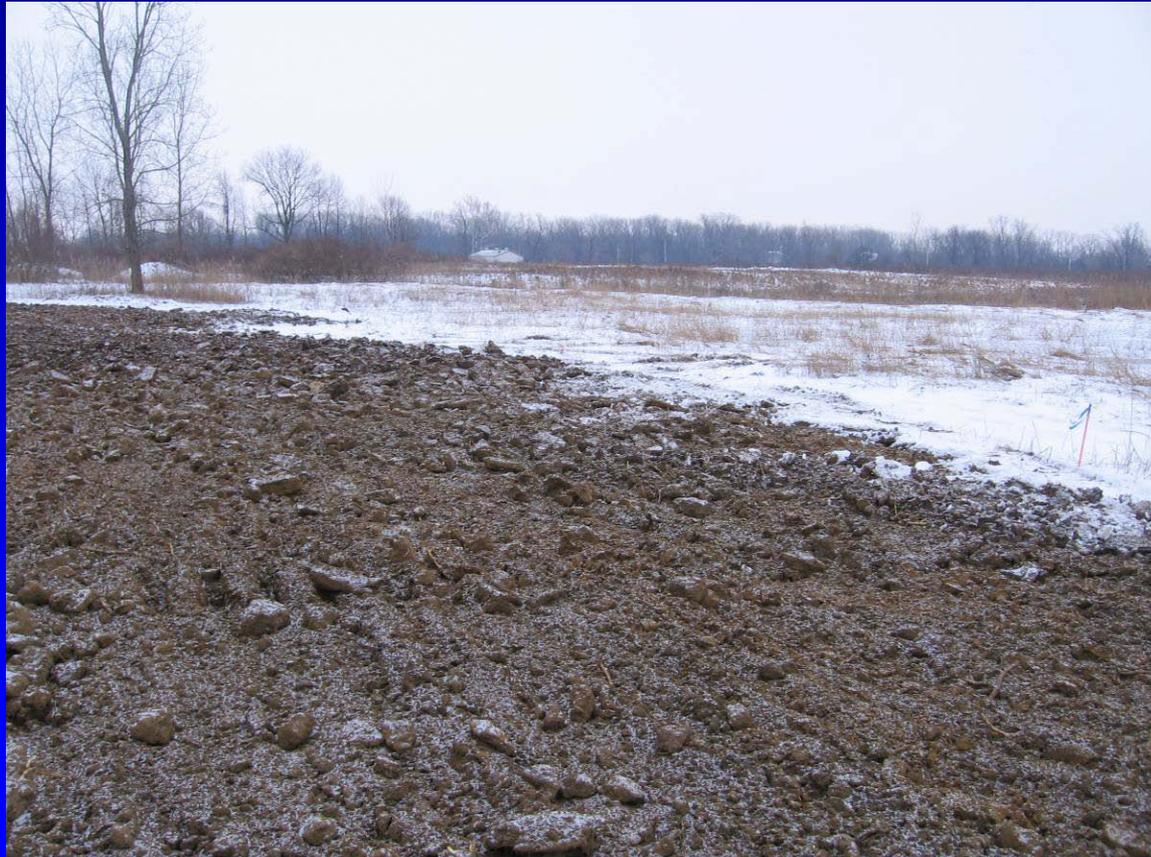
Backfilled excavation

At the completion of field activities, the treatment piles were placed back into the original excavation and graded.

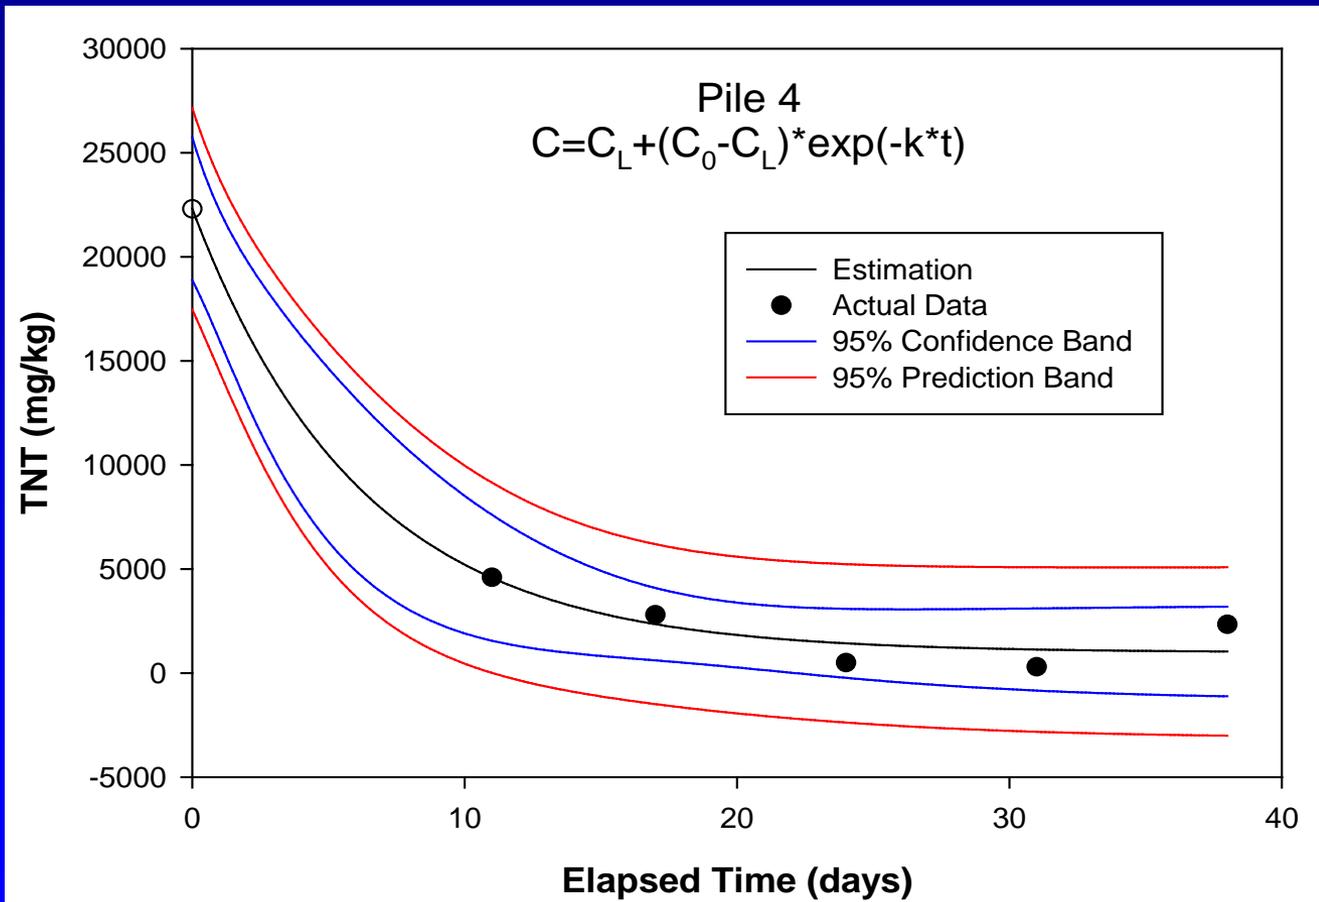
Non-linear Estimation of TNT - Pile 4

R² = 0.990
K = 0.16 day⁻¹
C₀ = 22,310
C_L = 989 mg/kg
Δ = 96%

Pile 1 - Control	Levels are below the RGO.
Pile 2 - Weekly	Unable to fit data, final levels were very low.
Pile 3 - Daily	Unable to fit data and levels are above RGO.
Pile 4 - Daily	1 st order regression of data successful.
Pile 5 - Daily	1 st order regression of data successful.
Pile 6 - Daily	All but initial samples are below RGO.
Pile 7 - Control	Unable to fit data and levels are above RGO.
Pile 8 - Weekly	Levels are below the RGO.

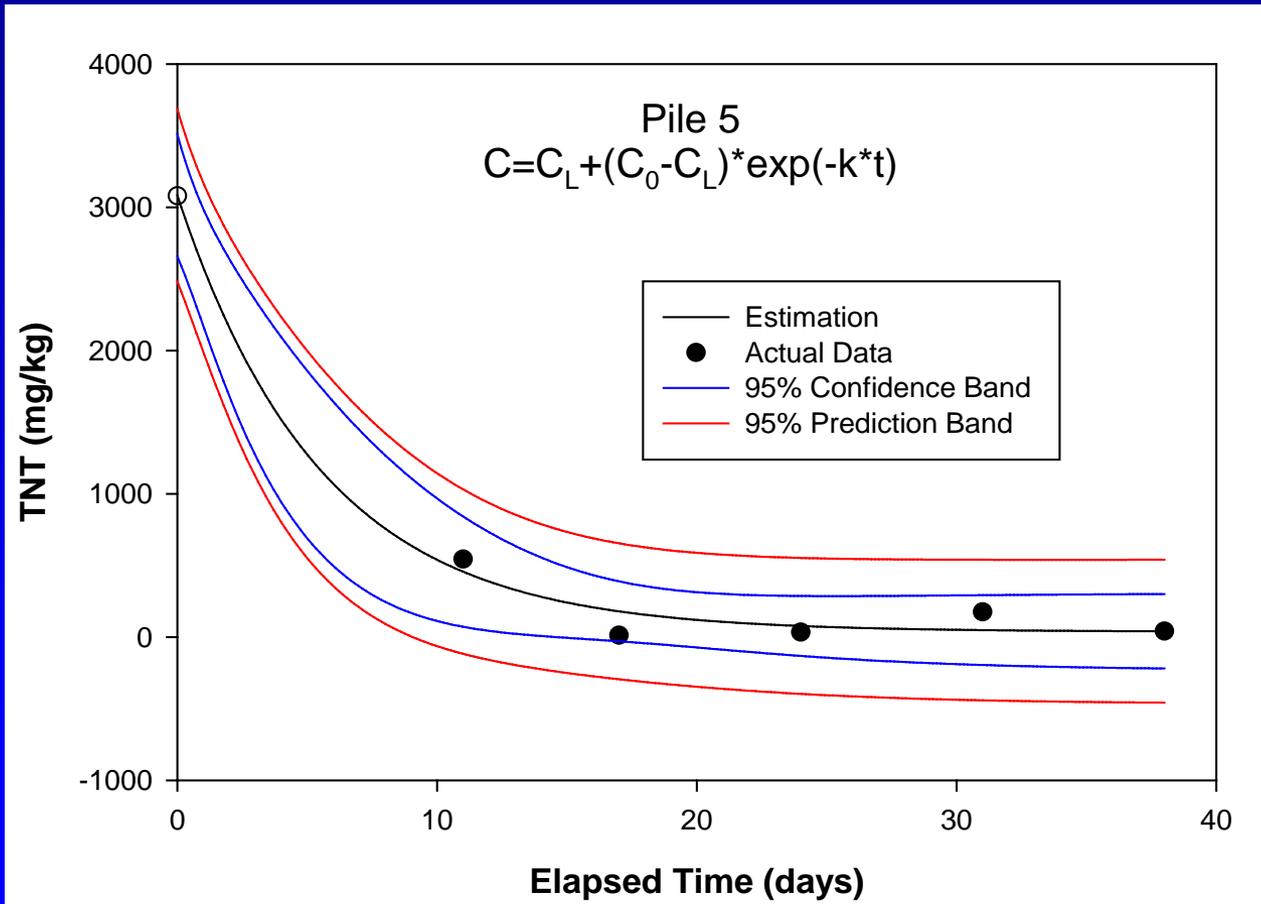
Non-linear Estimation of TNT in Pile 5

$R^2 = 0.993$
 $K = 0.18 \text{ day}^{-1}$
 $C_0 = 3084$
 $C_L = 37 \text{ mg/kg}$
 $\Delta = 99\%$
