**ORDNANCE AND EXPLOSIVES
RECURRING REVIEW**

**DOLLY SODS PROJECT
WEST VIRGINIA MANEUVER AREA/DOLLY SODS FORMERLY
USED DEFENSE SITE (FUDS) PROPERTY**

**DOLLY SODS WILDERNESS AREA,
MONONGAHELA NATIONAL FOREST, WEST VIRGINIA
SEPTEMBER 2011 – FINAL REPORT**

Prepared by: U.S. Army Corps of Engineers, Huntington District, Environmental and
Remediation Section

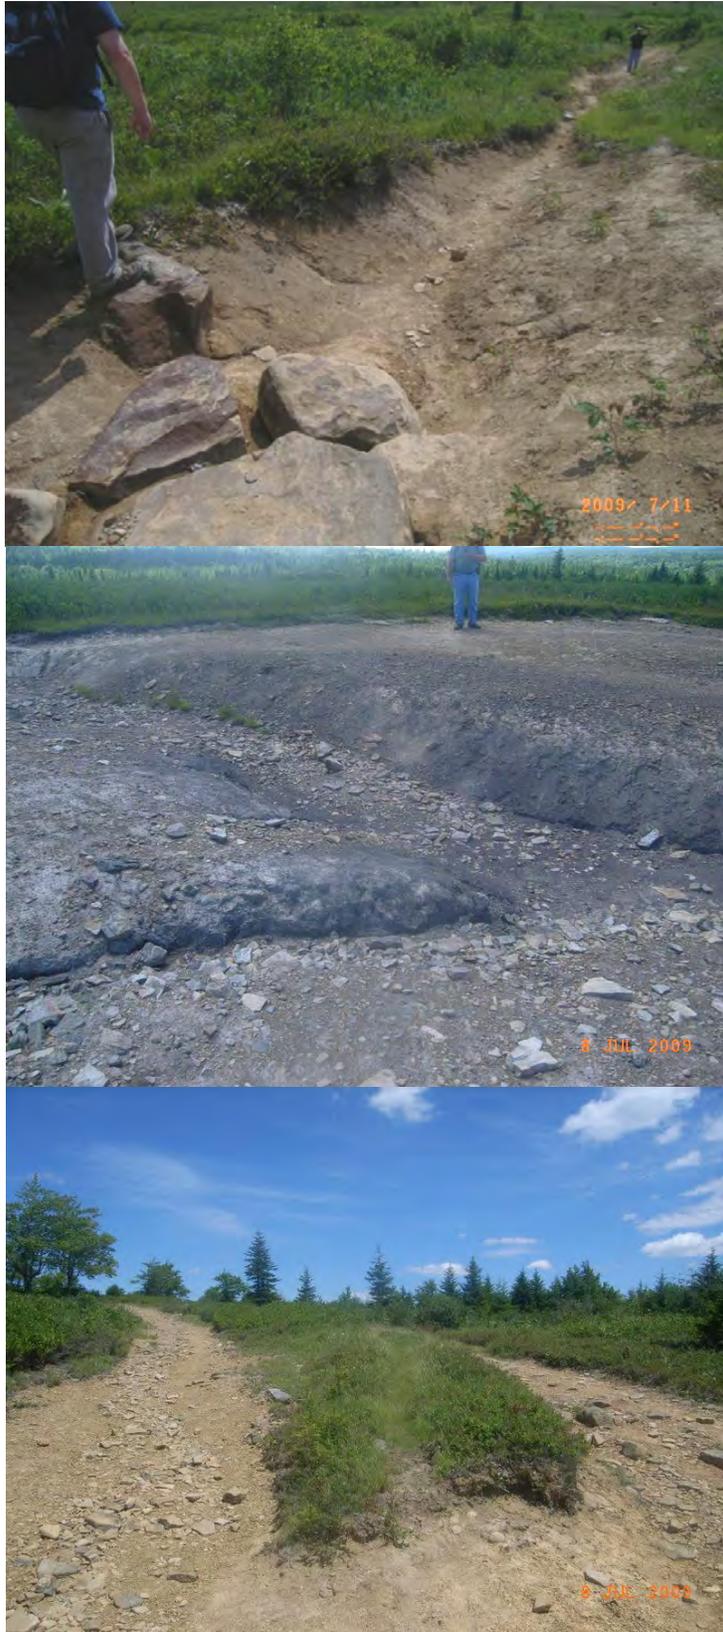
Figure 5. Examples of trail erosion concerns on Upper Red Creek Trail and Bear Rocks Trail

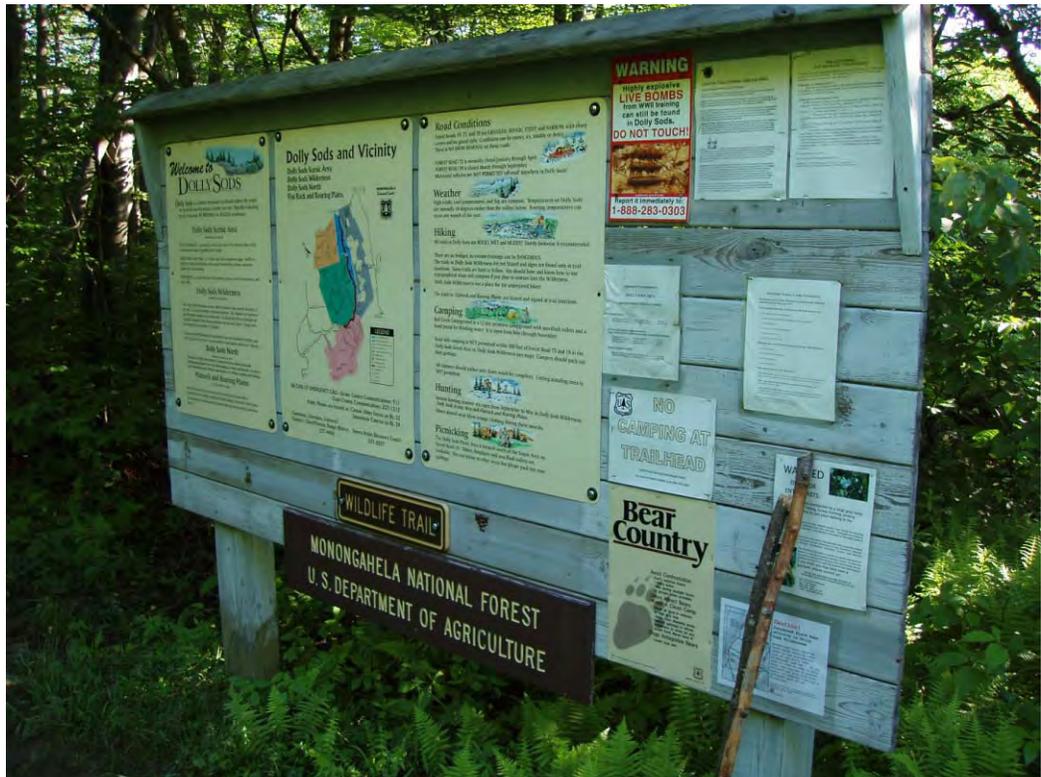
Photo Description:
Photo of the trailhead information sign located at the Wildlife Trail. Note the UXO Warning Sign located on the top right hand side of the sign.

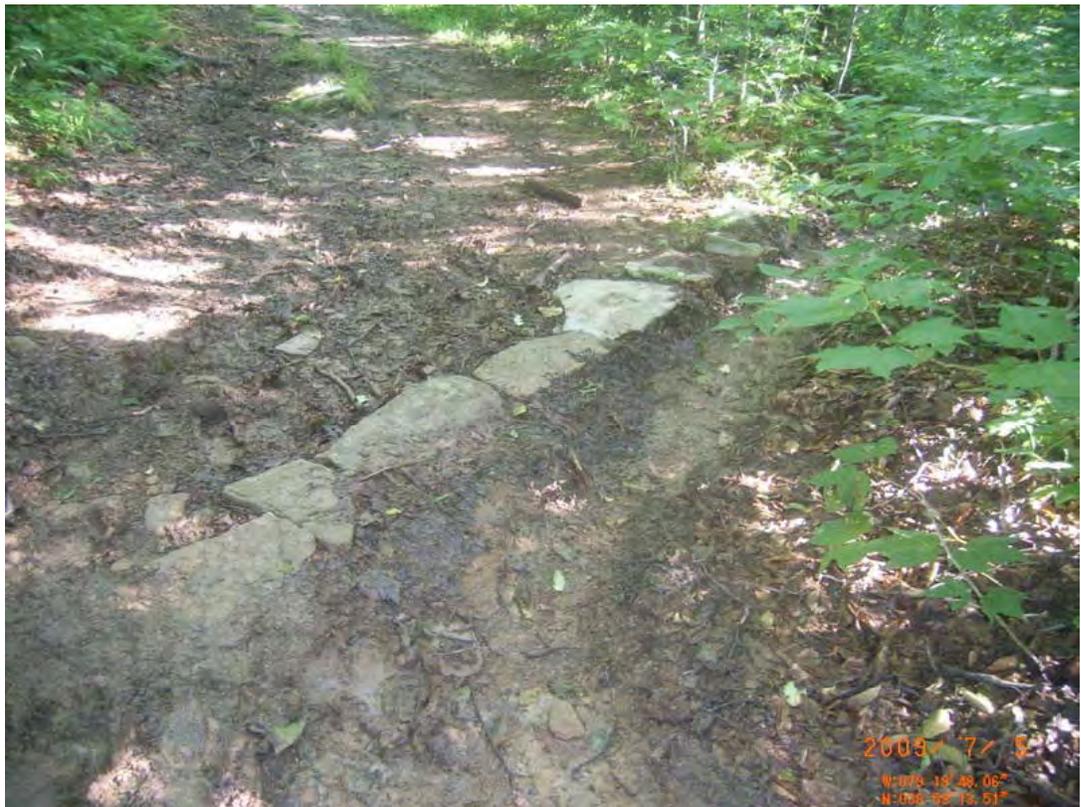
Photo Number:
2

Photo Description:
Photo of a stone diversion located on the Wildlife Trail. The diversion structure is used to transport water away from the trail and help ease erosion issues.

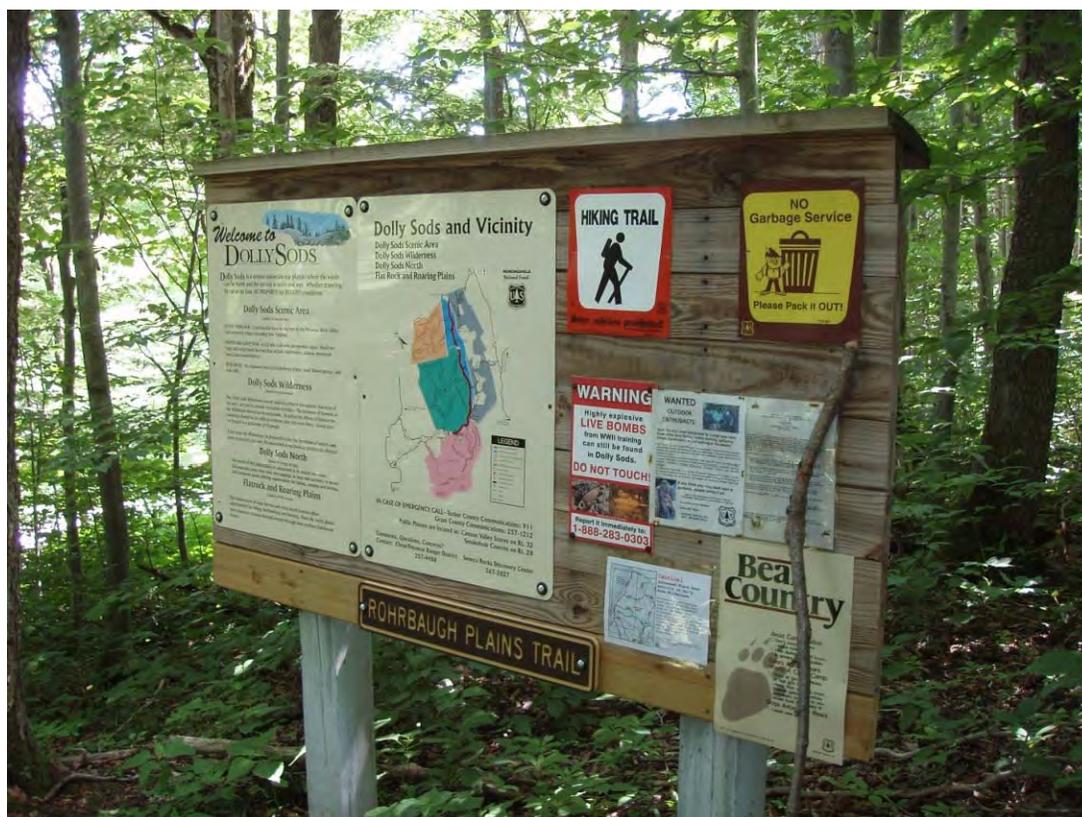
Photo Number:
8

Photo Description:
This photo shows
the trailhead sign
located at the
Rohrbaugh Plains
Trailhead. Note
the UXO Warning
Sign present in the
middle of the sign.

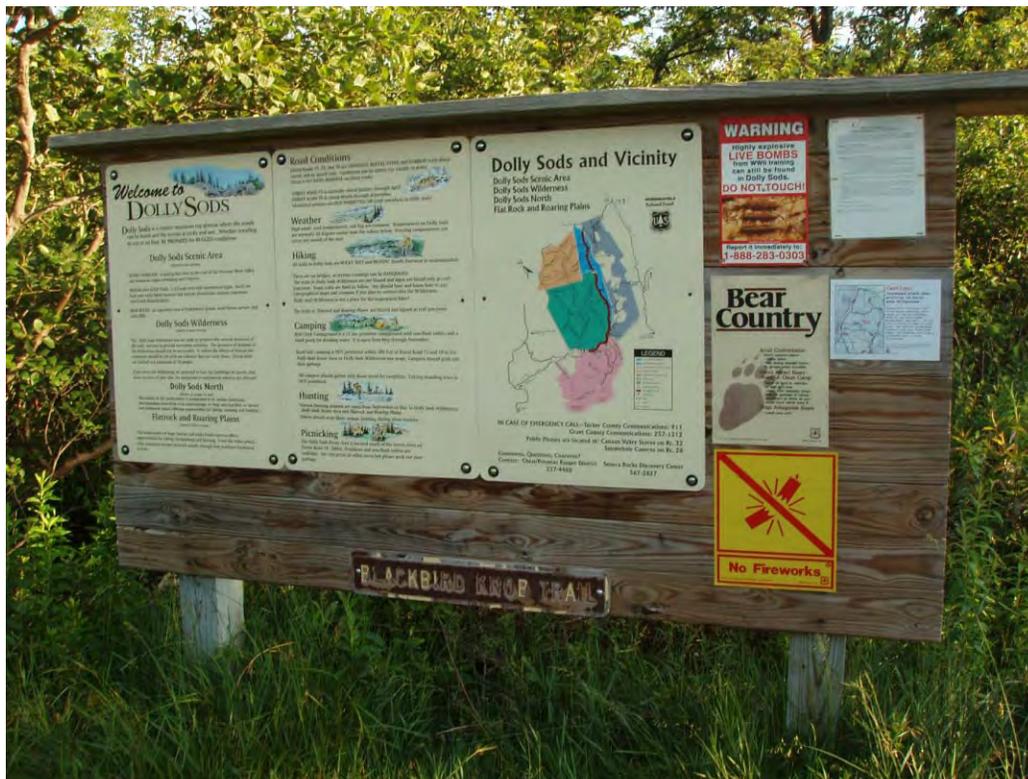
Photo Description:
This photo shows
the trailhead sign
located at the
Blackbird Knob
Trailhead. Note the
UXO Warning Sign
present on the
upper right hand
corner of the
sign.

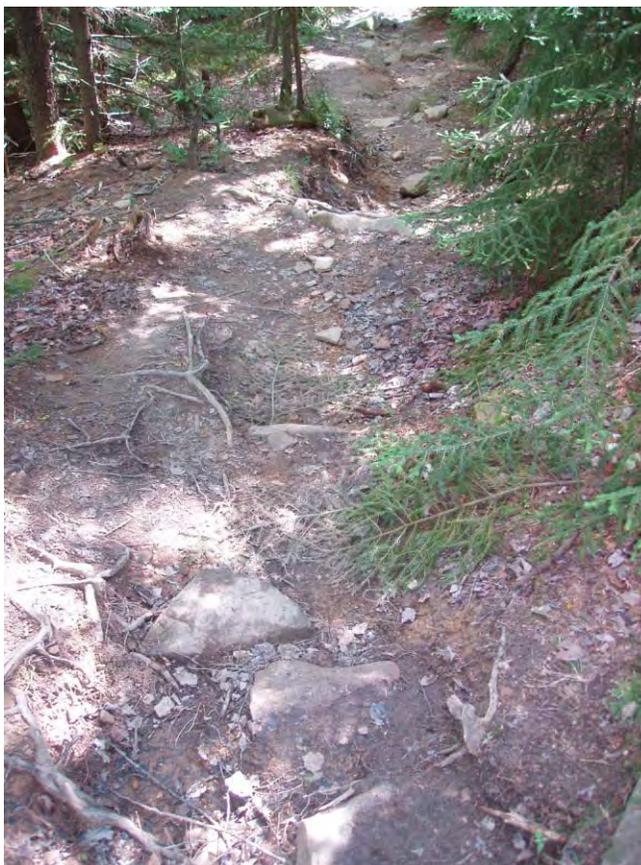
Photo Number:
12

Photo Description:
Area of trail
erosion >1 ft.
along the
Blackbird Knob
Trail.

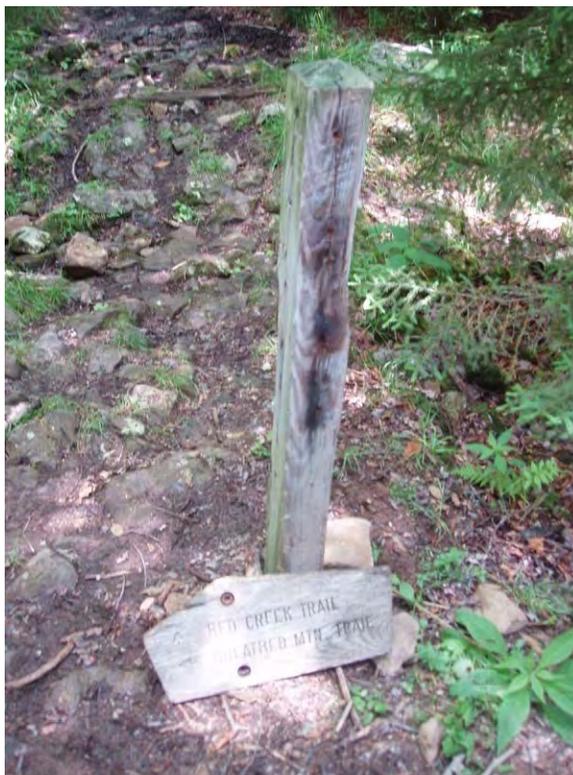
Photo Description:
View of the sign
marking the
intersection of Red
Creek and Breathed
Mountain Trails.
Note that the sign
had been knocked
down and was on
the ground.

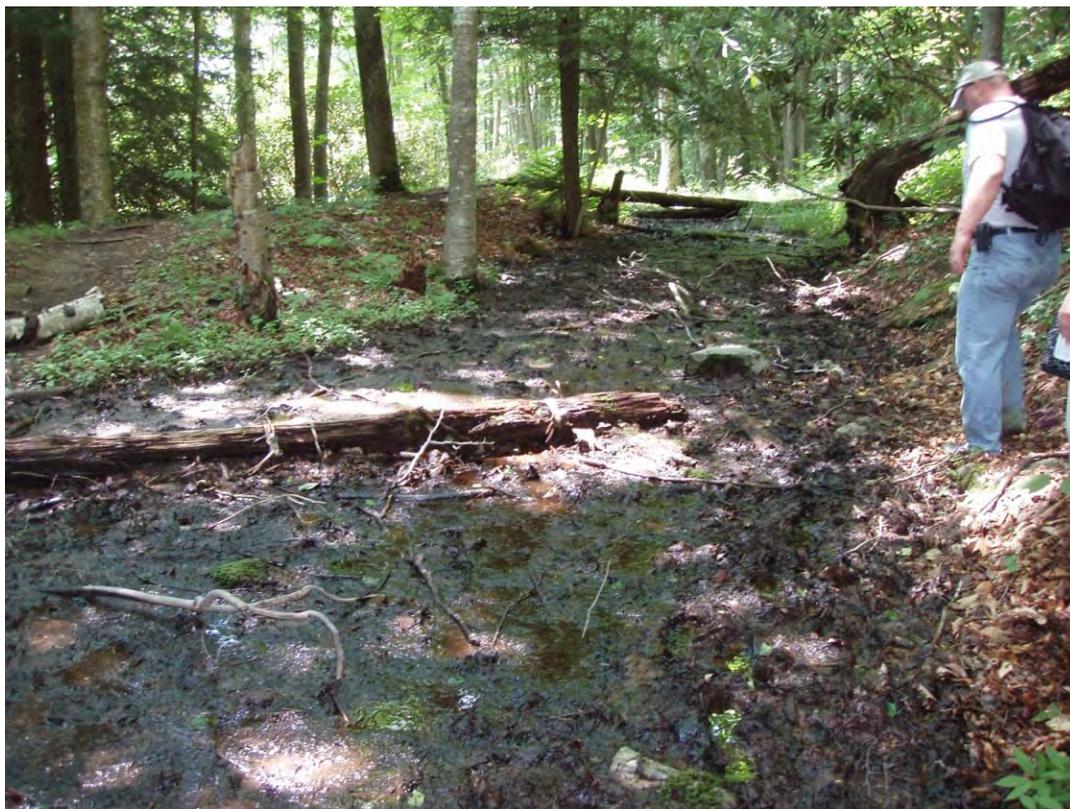
Photo Number:
18

Photo Description:
Area along Red
Creek Trail where
water had ponded
on the trail.

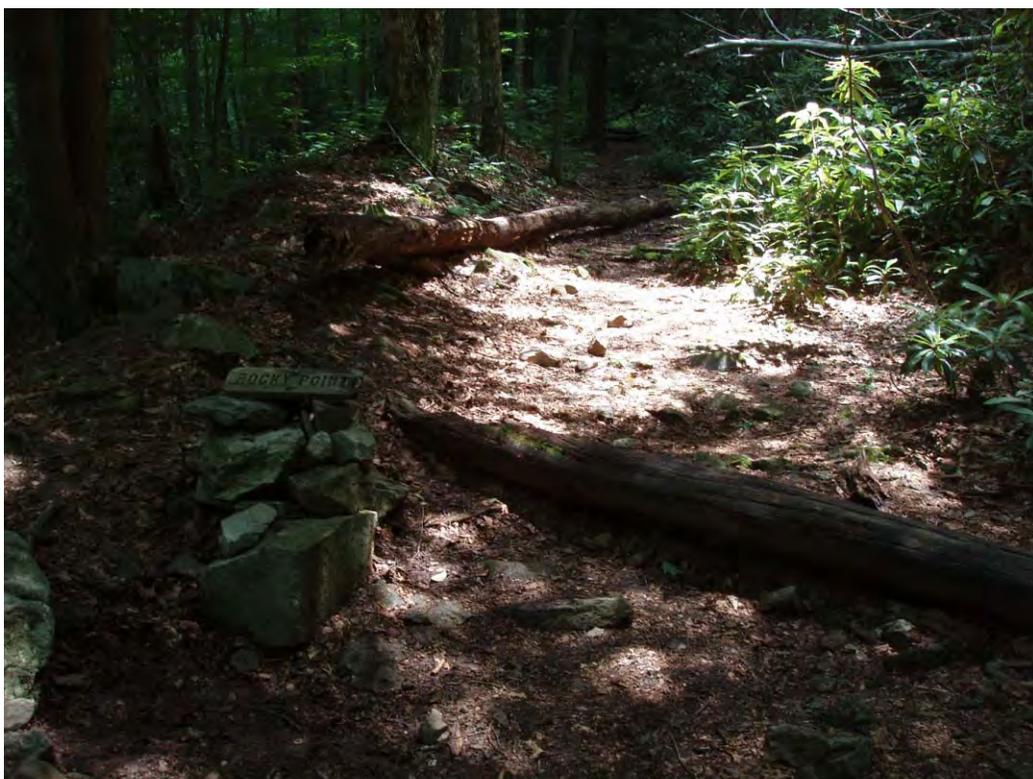
Date of Photo:
July 7, 2009

Photo Description:
Photo of the
intersection of
Red Creek and
Rocky Point Trail.
Note the sign had
been knocked
down and had to
be replaced at the
top of the cairn.

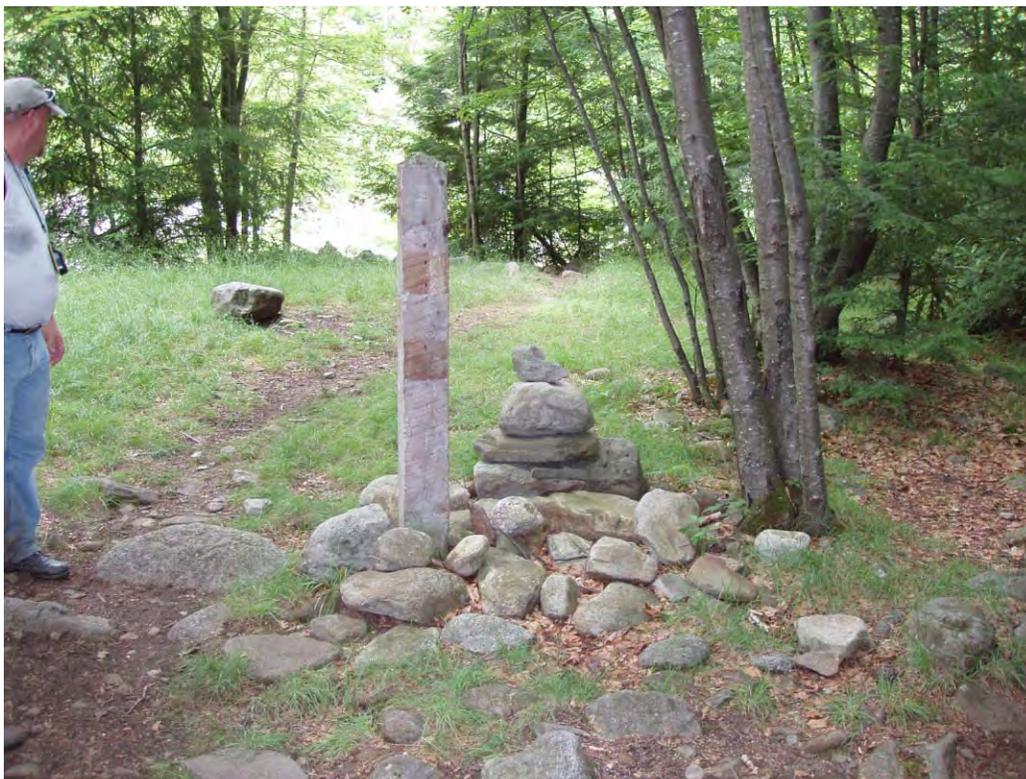
Photo Description:
Marker noting the
intersection of Big
Stonecoal and Red
Creek Trails.
Note that the trail
sign is no longer
present.

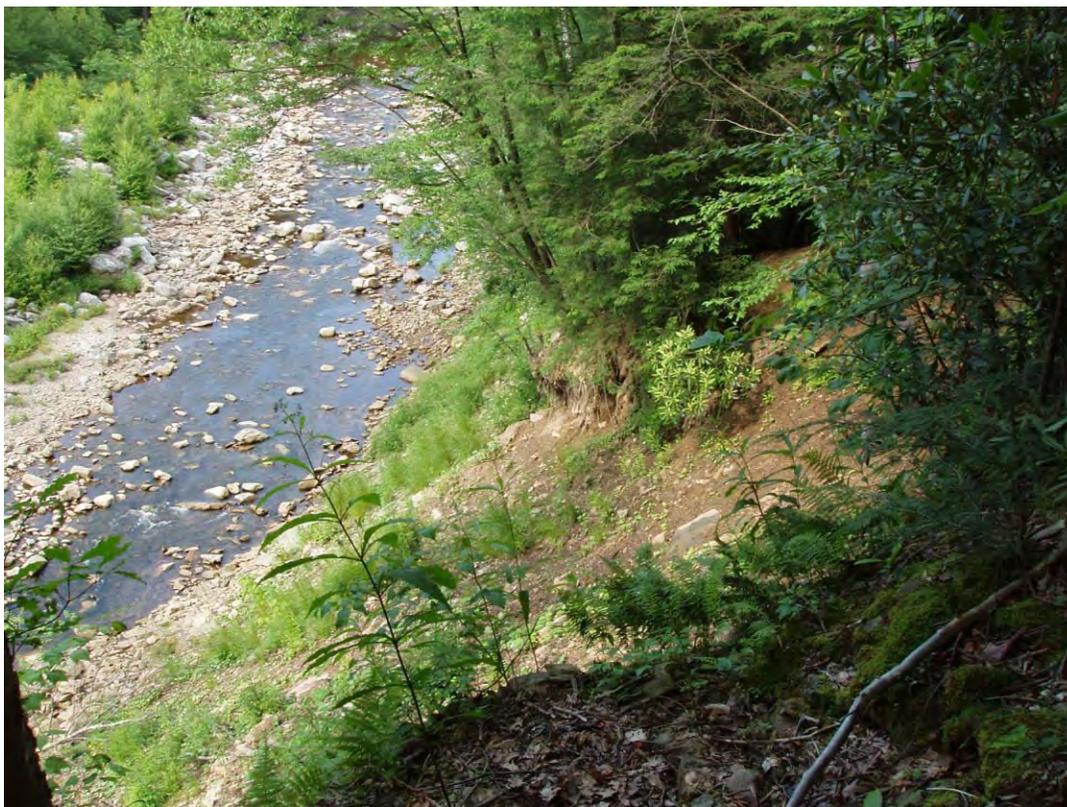
Photo Number:
24

Photo Description:
View of a washout
between Red
Creek and Red
Creek Trail.

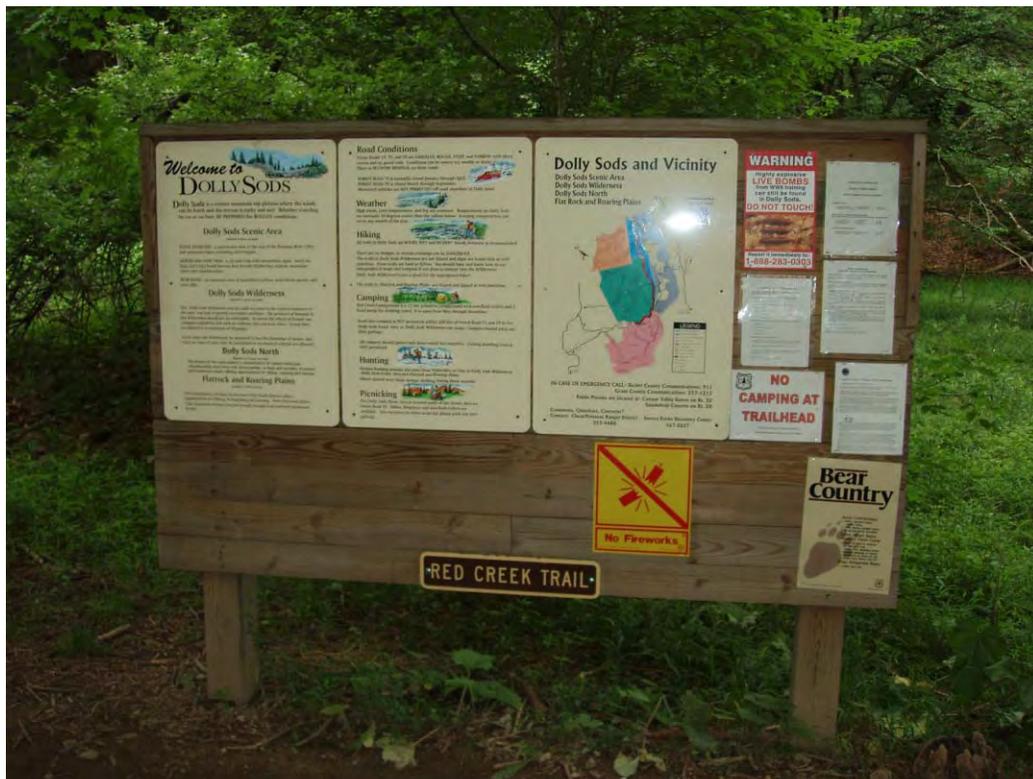
Photo Description:
View of the
information sign
at the entrance of
the Red Creek
Trail. Note the
UXO Warning
Sign located at the
upper right hand
corner of the kiosk.

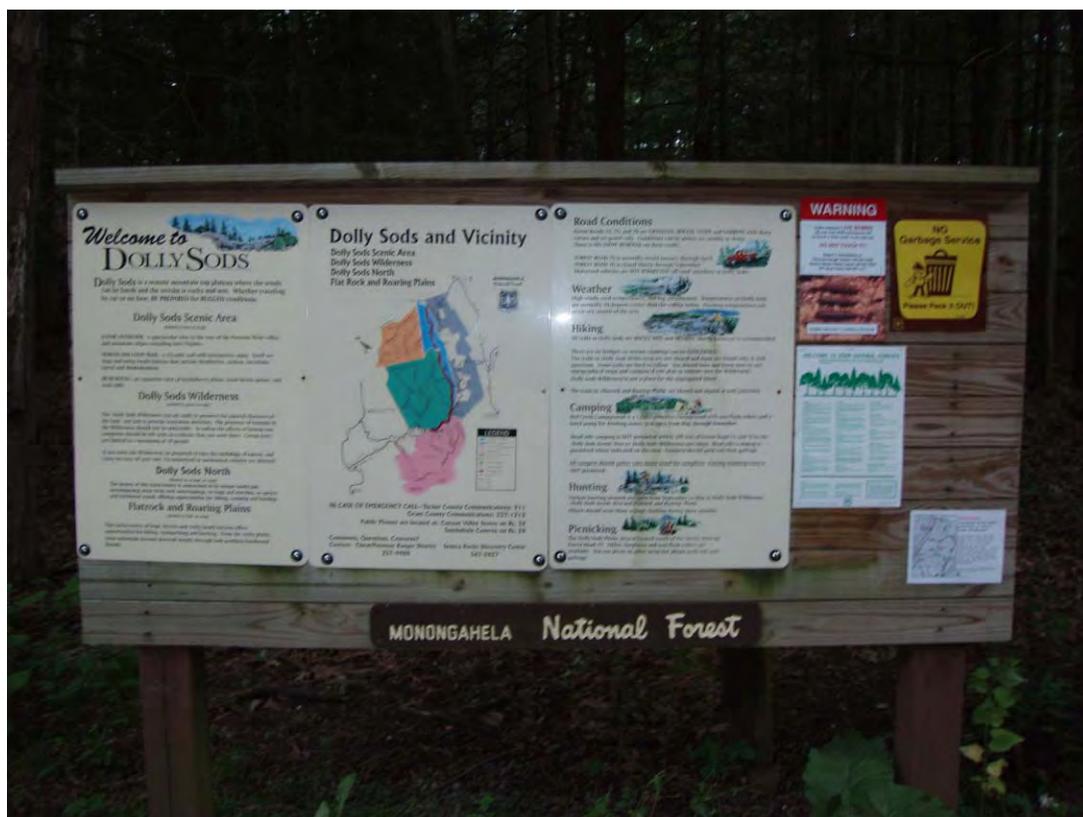
Photo Number:
26

Photo Description:
Entry sign into the
Dolly Sods
Wilderness Area.
Note the UXO
Warning Sign
located at the
upper right hand
corner of the
kiosk.

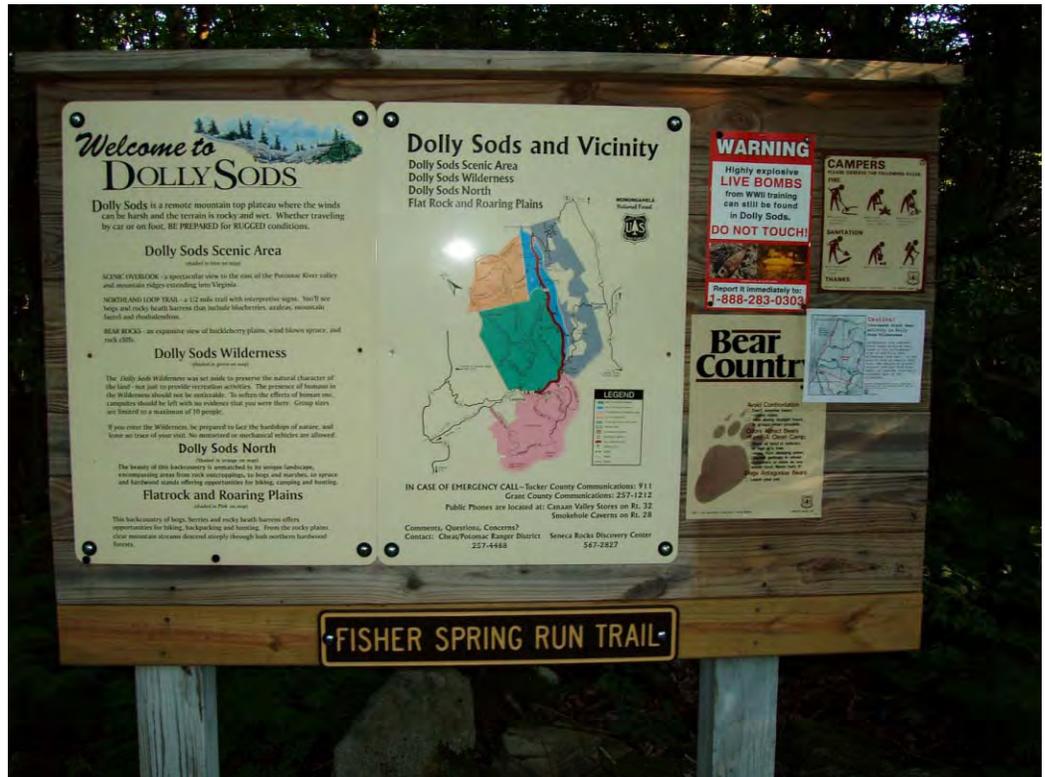
Photo Description:
View of the
information sign
at the entrance of
the Fisher Spring
Run Trail. Note
the UXO Warning
Sign located at the
upper right hand
corner of the kiosk.

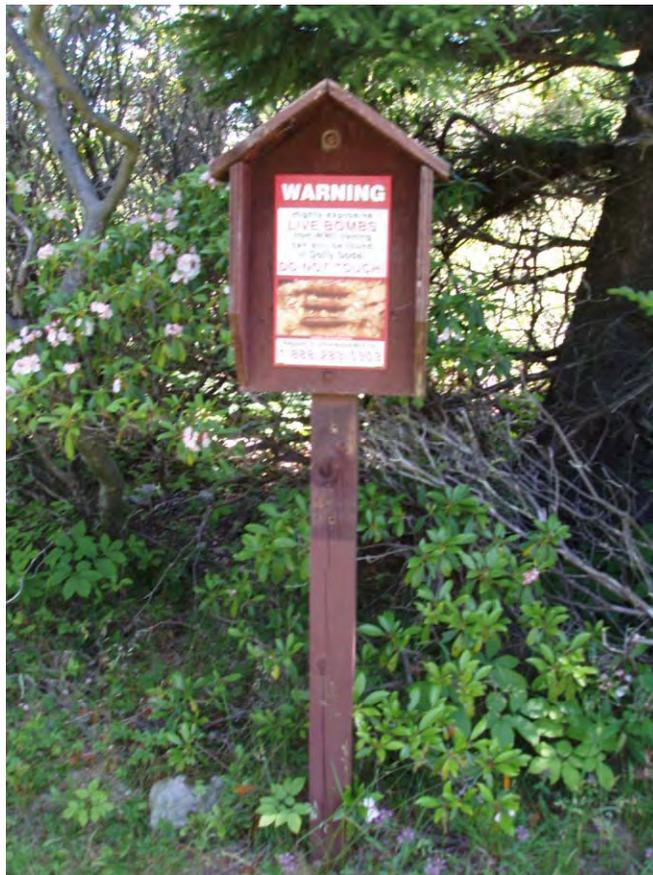
Photo Description:
View of the
trailhead marker
located at the
Northland Loop
Trail. Note the
presence of the
UXO Warning
Sign.

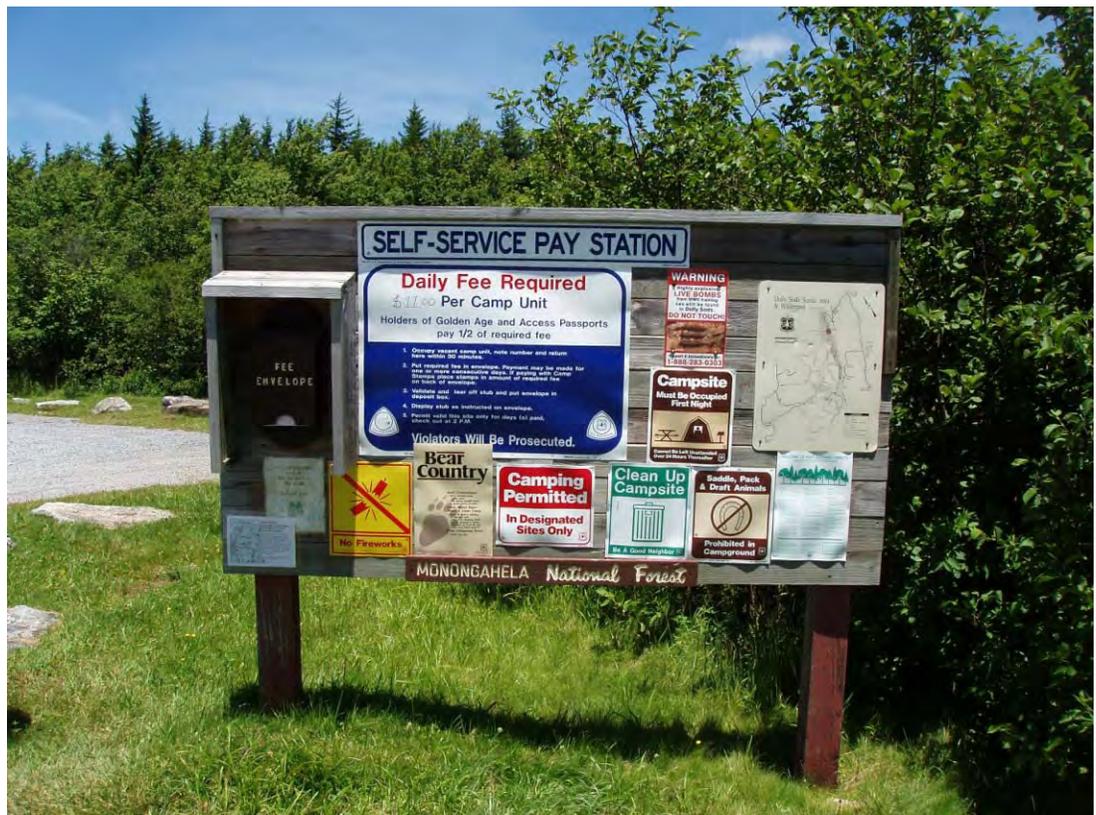
Photo Number:
32

Photo Description:
View of the
informational sign
located at the Red
Creek
Campground.
Note the UXO
Warning Sign
located in the
upper right hand
corner of the
kiosk.

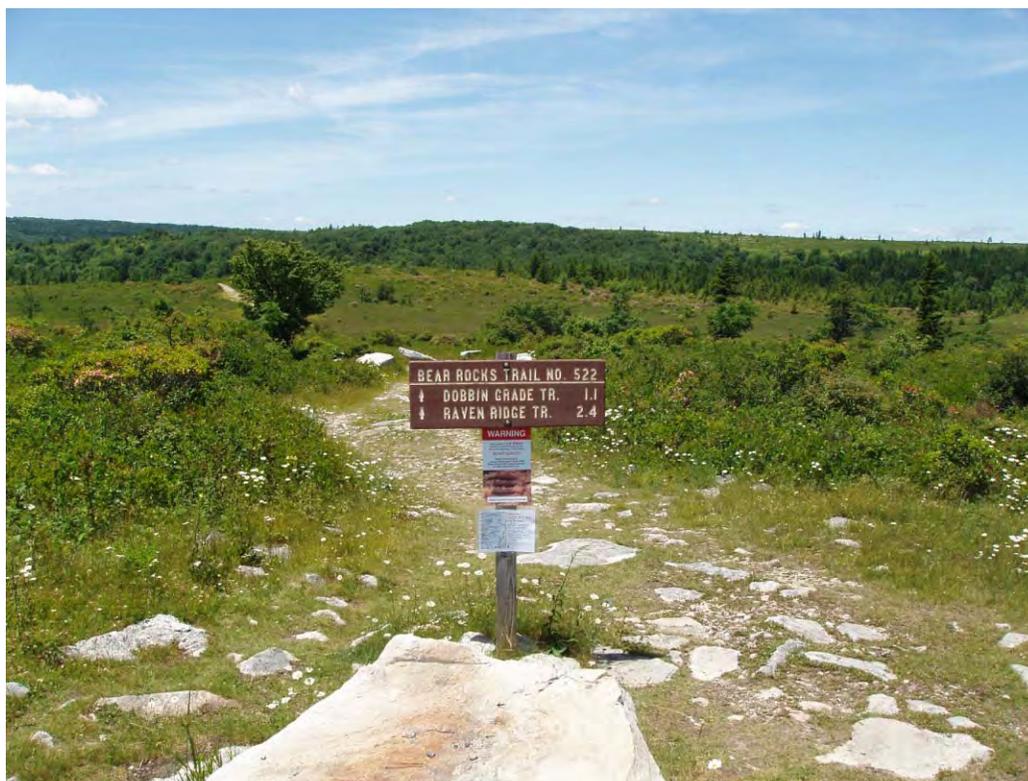
Photo Description:
View of the Bear
Rocks Trailhead
Sign. Note the
presence of the
UXO Warning
Sign.

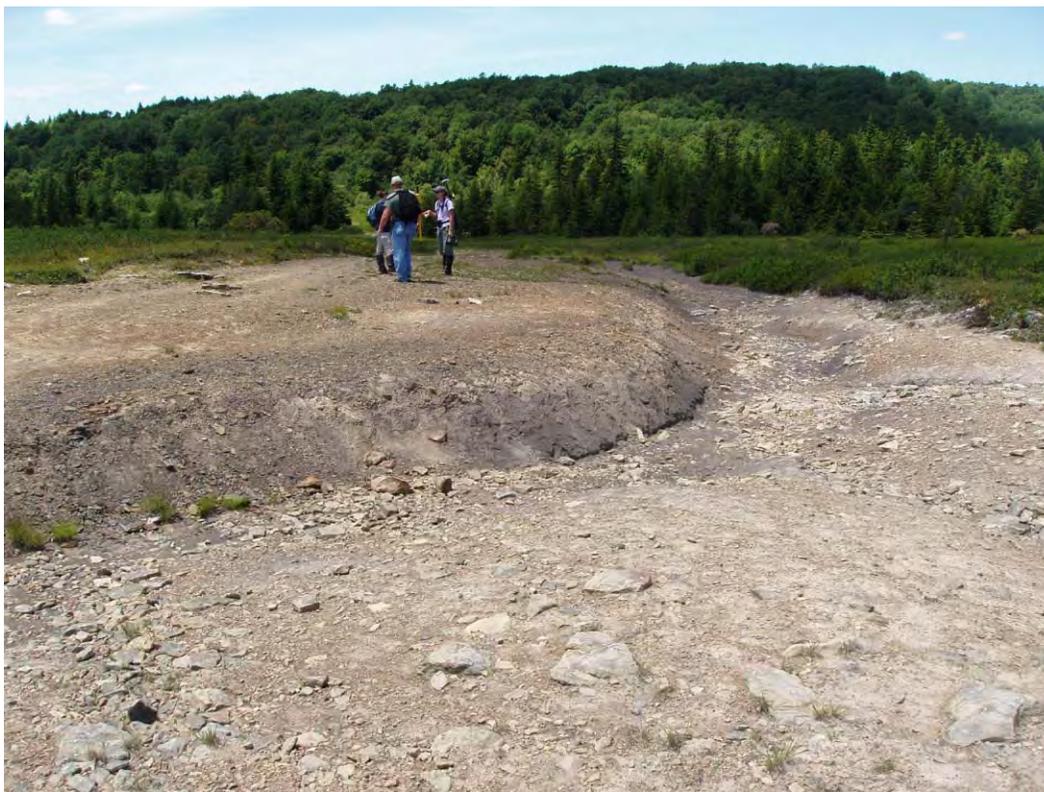
Photo Location:
Bear Rocks Trail

Photo Description:
View of
significant erosion
located along Bear
Rocks Trail.

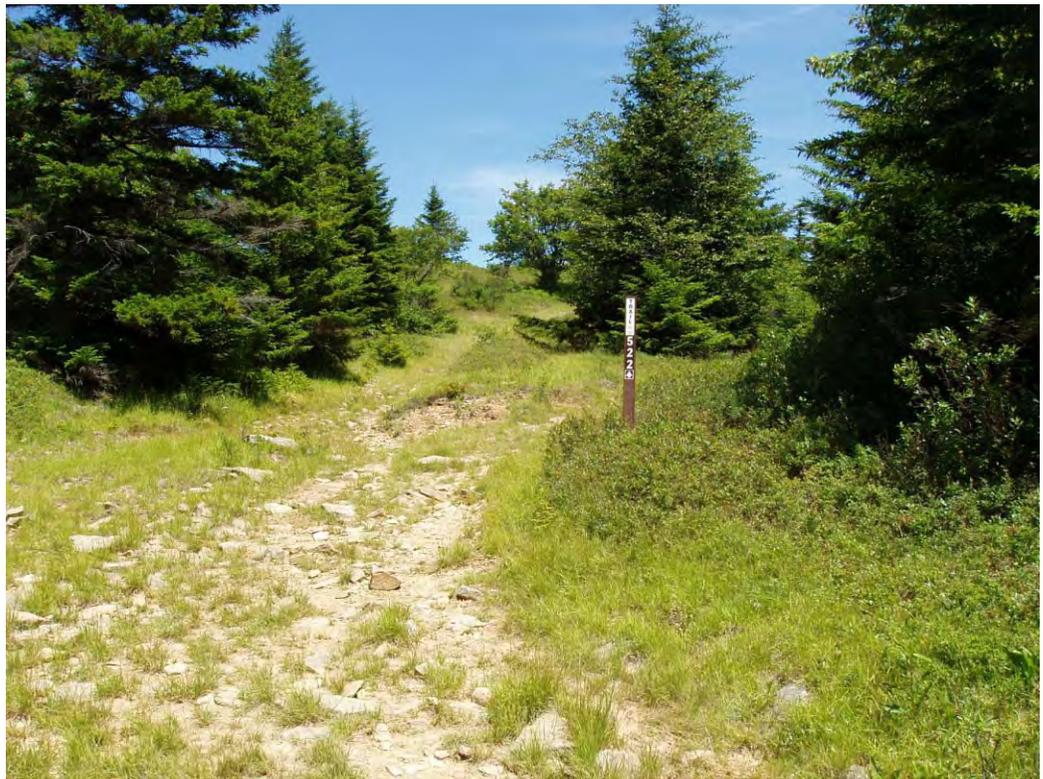
Date of Photo:
July 8, 2009

Photo Description:
View of "newer"
trail markers
along Bear Rocks
Trail. These trail
markers are
predominately
found in the
northern portion
of the Dolly Sods
Wilderness Area.

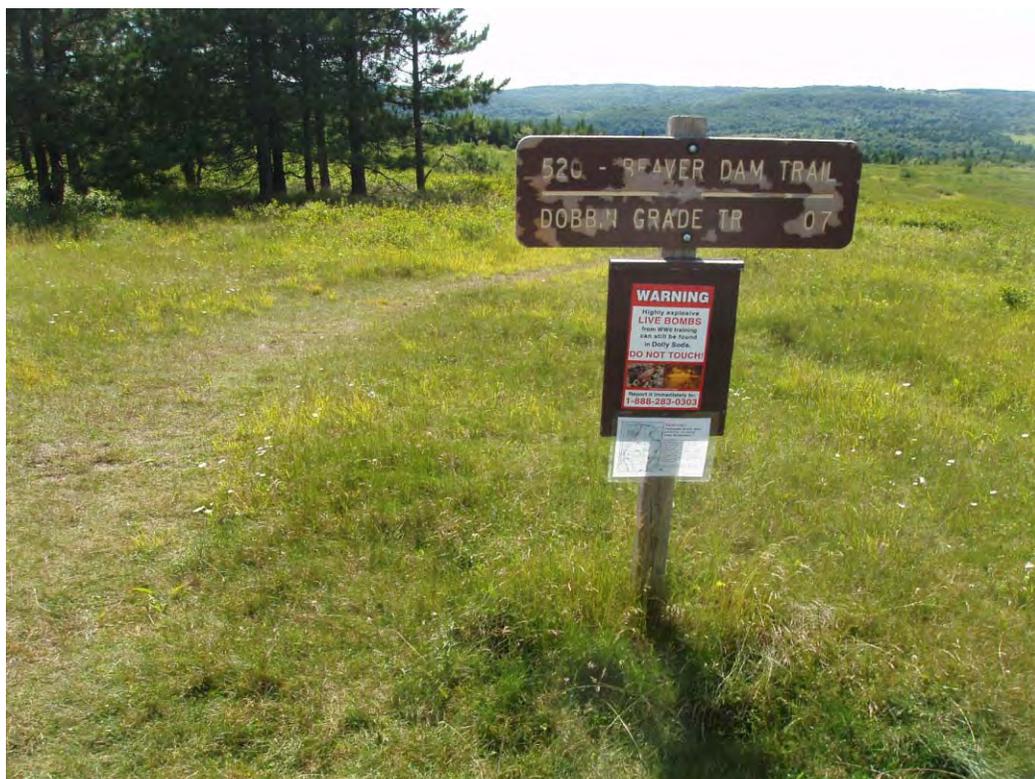
Photo Location:
Beaver Dam Trail

Photo Description:
View of the
Beaver Dam
Trailhead Marker.
Note the UXO
Warning sign
present on the
trailhead marker.

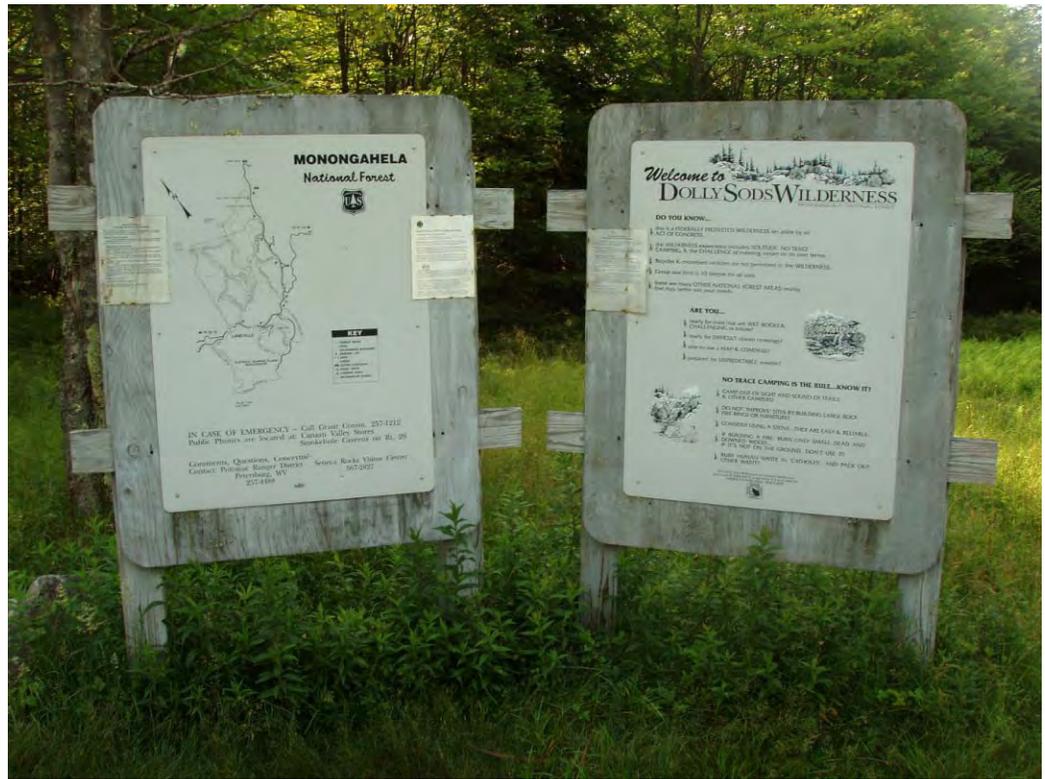
Date of Photo:
July 9, 2009

Photo Description:
View of
informational
kiosk located at
the Dolly Sods
Wilderness Area
entrance. Note
the UXO Warning
Sign was missing.

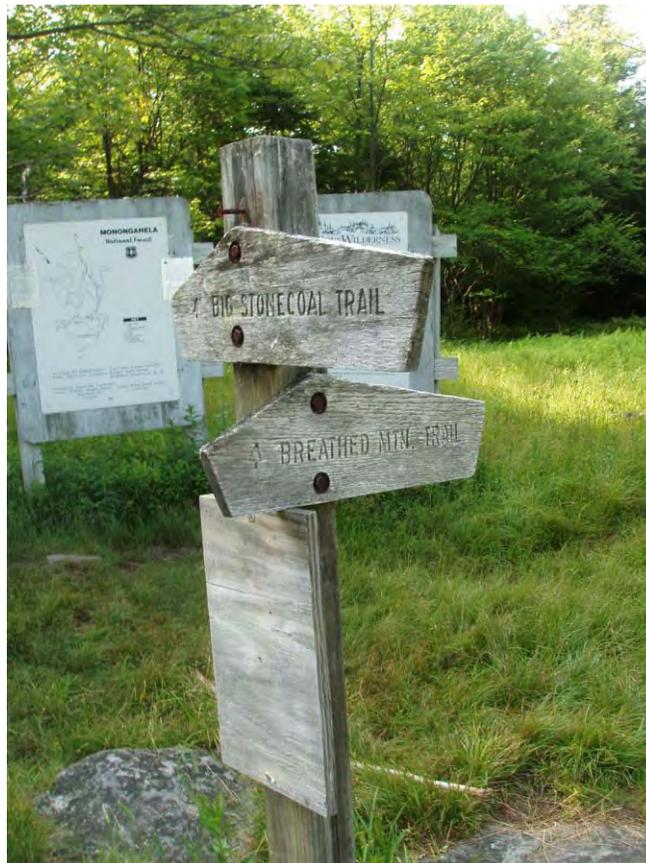
Photo Location:
Intersection of Big
Stonecoal and
Breathed
Mountain Trails

Photo Description:
Trailhead markers
located at the
intersection of the
Big Stonecoal and
Breathed
Mountain Trails.
Note the UXO
Warning sign at
this location had
been removed.

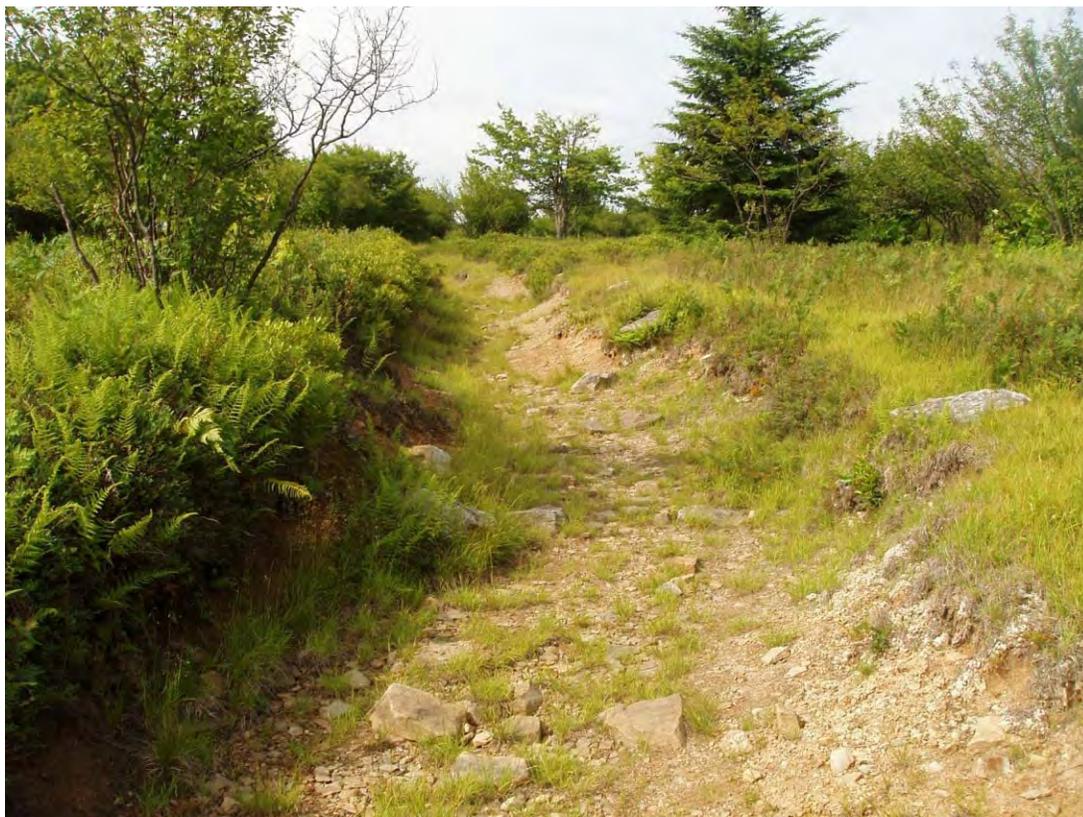
Photo Number:
52

Photo Description:
View of area of
severe erosion
located along the
Rocky Ridge
Trail. The erosion
was over 3 ft.
deep in some
locations. Since
the erosion has
taken place, a new
trail has been
created to the
south of the old
trail.

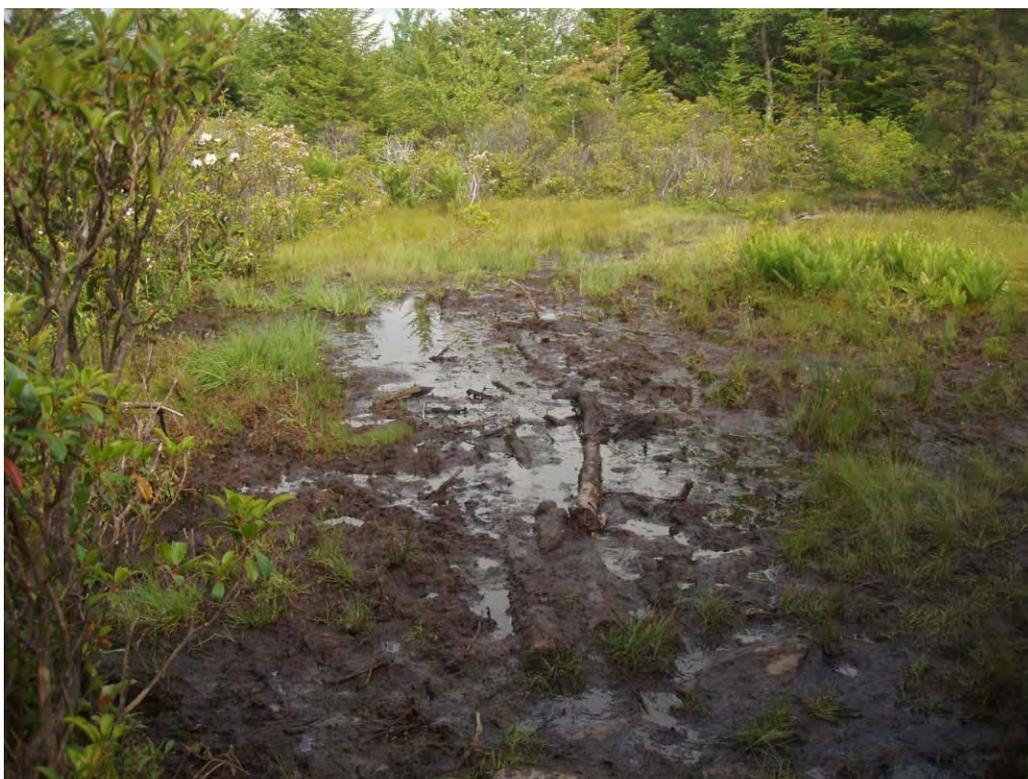
Photo Location:
Breathed
Mountain Trail

Photo Description:
Area along
Breathed
Mountain Trail
where water had
ponded on the
trail.

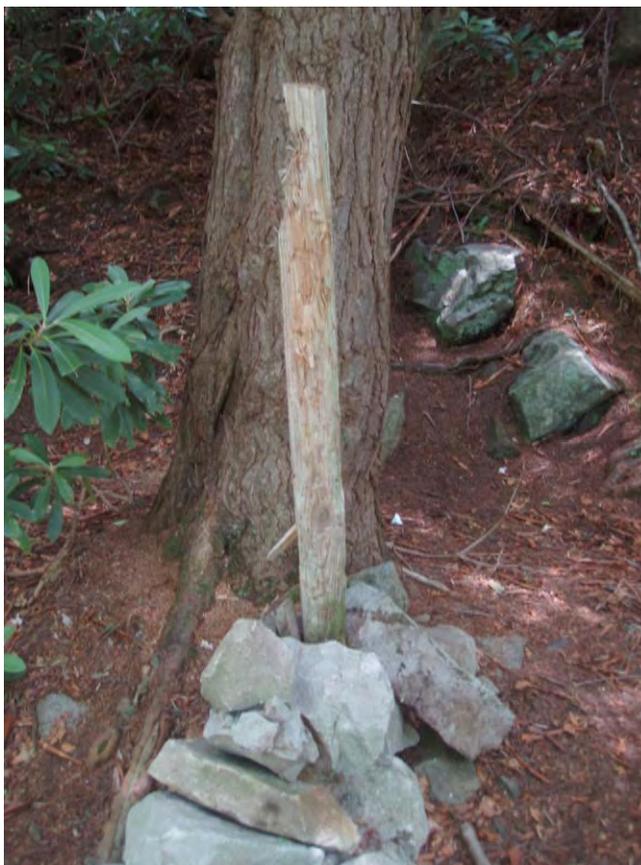
Photo Number:
60

Photo Description:
View of sign post
located at the
intersection of the
Rocky Point and
Bog Stonecoal
Trails. Note that
the signage had
been removed.

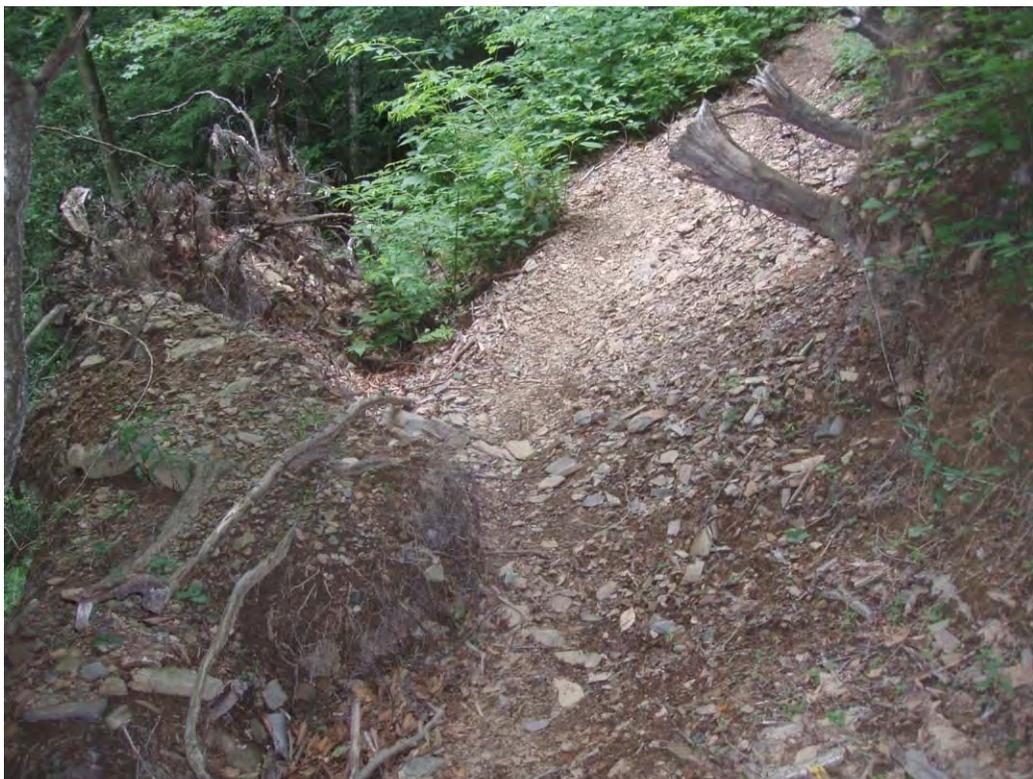
Photo Location:
Little Stonecoal
Trail

Photo Description:
View of downed
tree crossing the
Little Stonecoal
Trail.

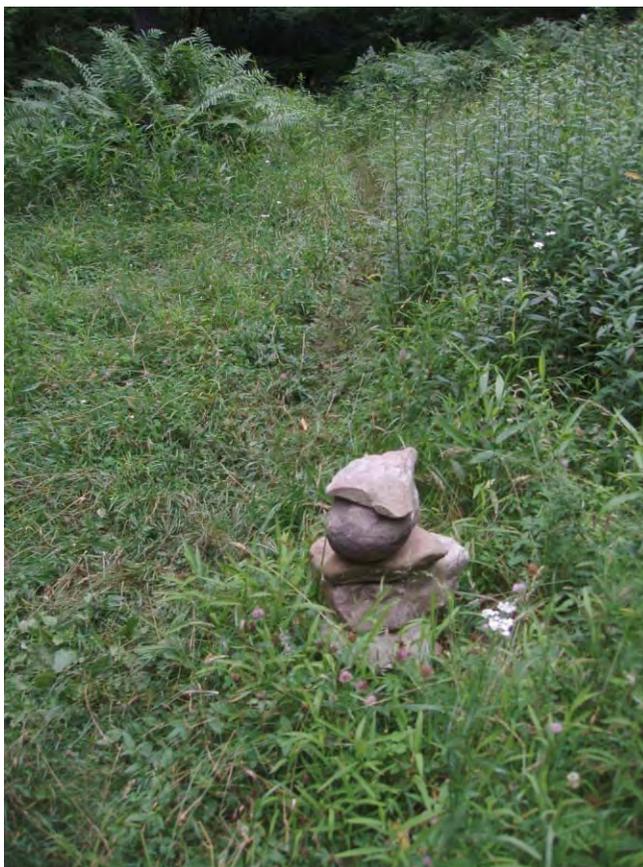
Photo Number:
66

Photo Description:
View of cairn
located at the
intersection of
Little Stonecoal
and Red Creek
Trails. Note there
was no trail sign
present.

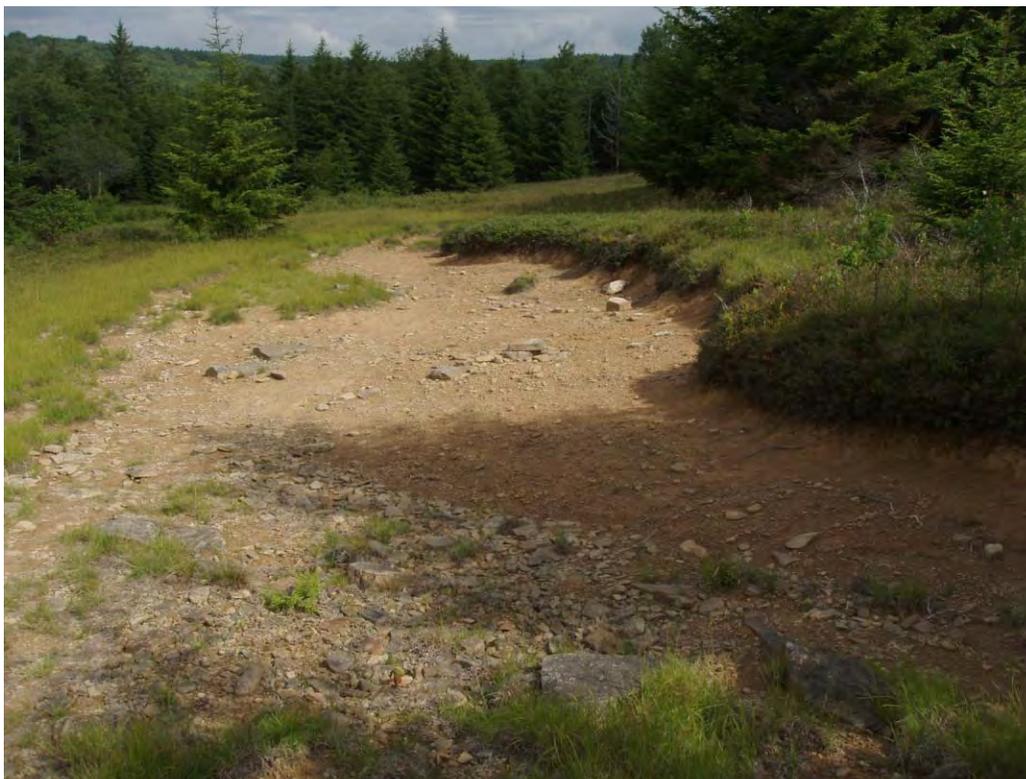
Photo Location:
Blackbird Knob
Trail

Photo Description:
View of trail
erosion located on
Blackbird Knob
Trail just east of
the Left Fork of
Red Creek.
