**ORDNANCE AND EXPLOSIVES
RECURRING REVIEW**

**DOLLY SODS PROJECT
WEST VIRGINIA MANEUVER AREA/DOLLY SODS FORMERLY
USED DEFENSE SITE (FUDS) PROPERTY**

**DOLLY SODS WILDERNESS AREA,
MONONGAHELA NATIONAL FOREST, WEST VIRGINIA
SEPTEMBER 2011 – FINAL REPORT**

Prepared by: U.S. Army Corps of Engineers, Huntington District, Environmental and
Remediation Section

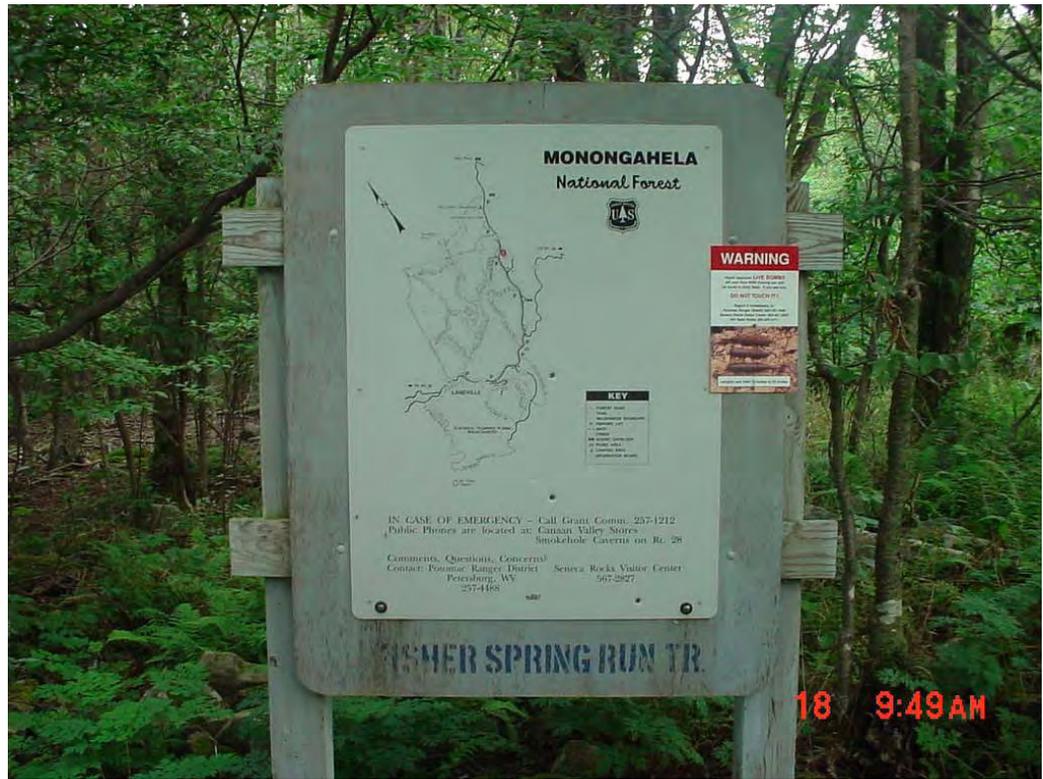
Photo Number:
1-Revisit

Description of
Photo:
Fischer Spring
Run Trailhead
sign

Comments on
Differences
Between the Two
Photos:
The sign at the
trailhead of the
Fisher Spring Run
Trail has been
replaced since the
2003 site visit.
The new trailhead
sign still contains
the UXO warning
sign.

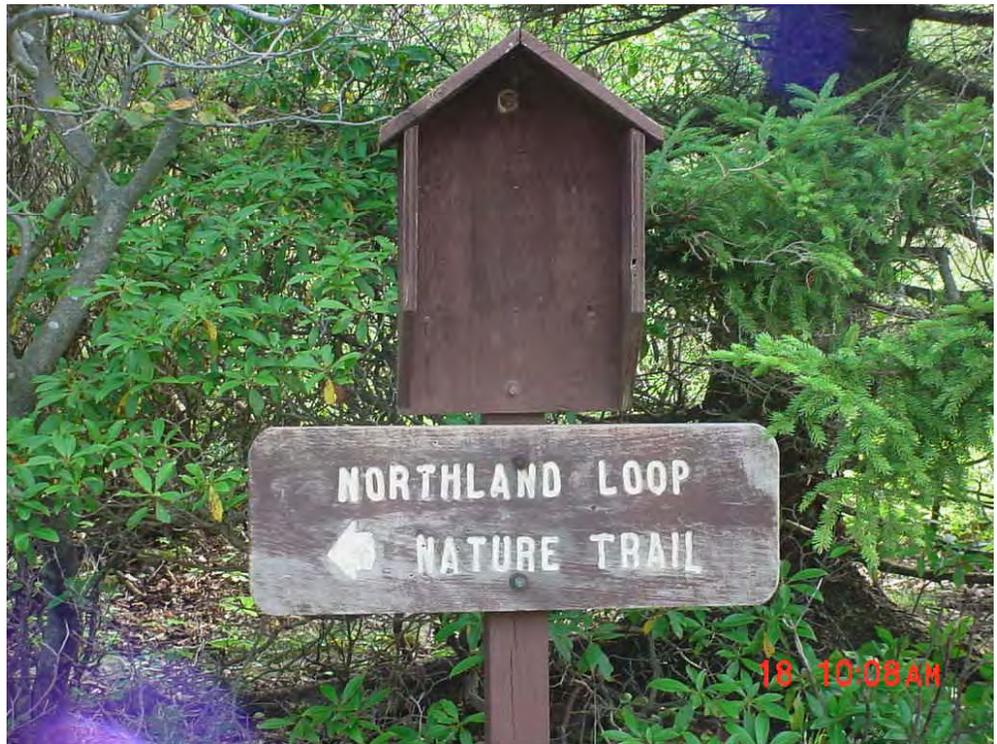
Photo Number:
2-Revisit

Description of Photo:
Northland Loop Nature
Trailhead sign

Comments on
Differences Between the
Two Photos:
The UXO warning sign
in the most recent photo
has been replaced and
contains the proper
UXO reporting
properties. It should be
noted that this is the
southern end entrance to
the trail. The northern
end of the trail (Photo 4)
does not contain a
warning sign.

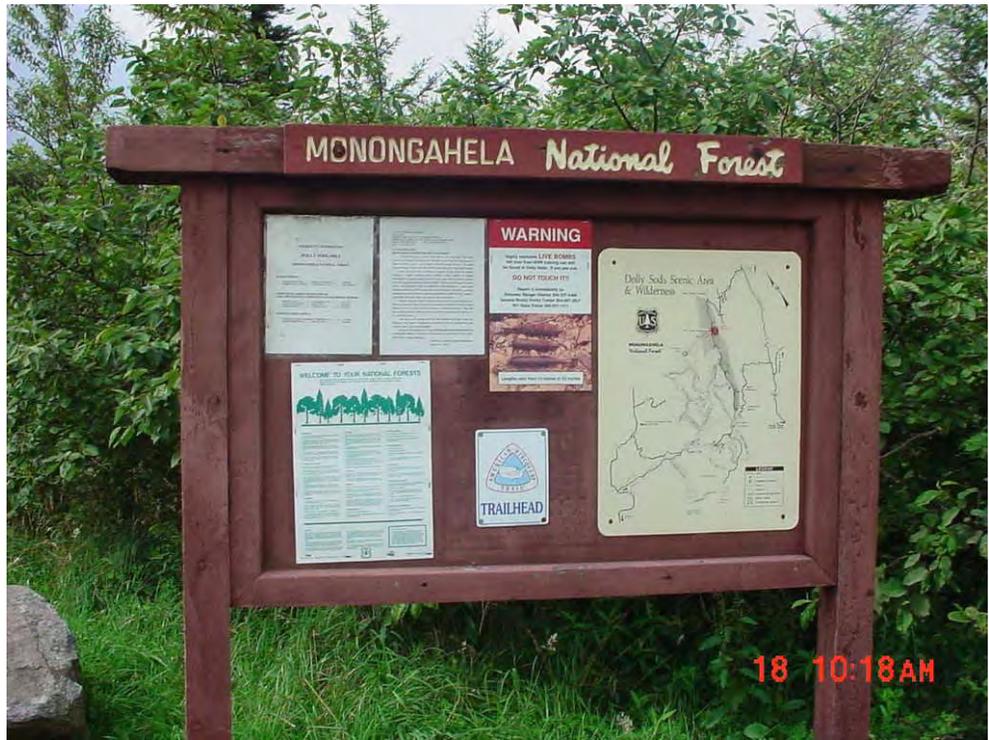
Photo Number:
3-Revisit

Description of Photo:
Red Creek Campground
sign

The original Red Creek
Campground sign has
been replaced since the
2003/04 five-year
recurring review. The
UXO warning sign is
still visible on this new
campground sign.

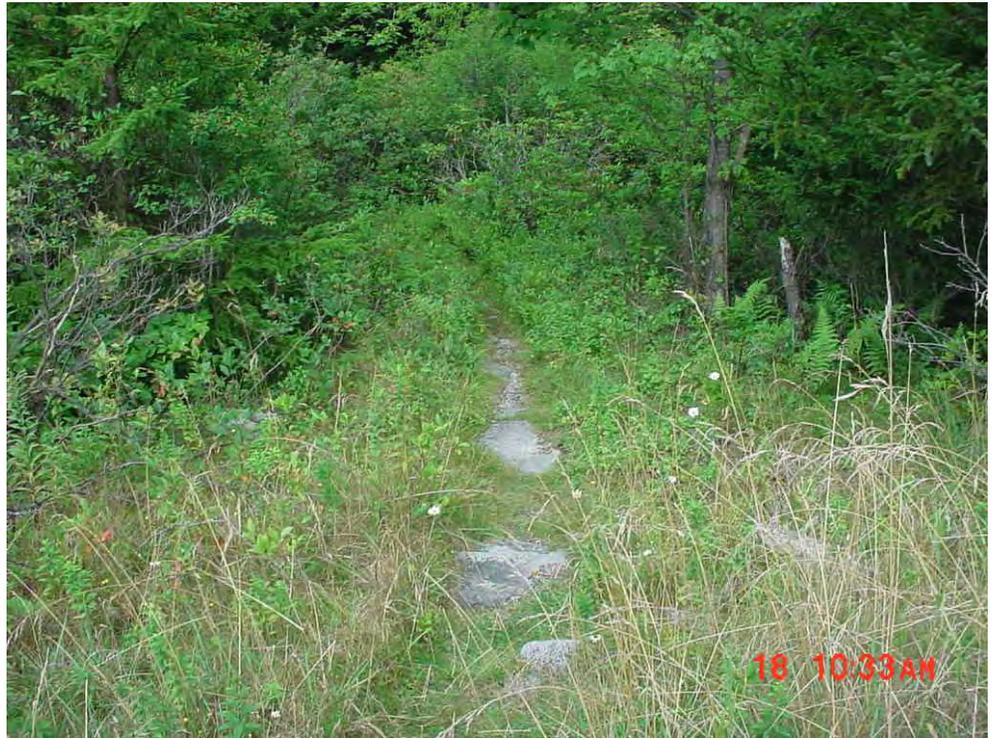
Photo Number:
4-Revisit

Description of Photo:
Entrance to the
Northland Loop Nature
Trail.

Comments on
Differences Between the
Two Photos:
A Northland Loop
Nature Trail sign has
been added to the
entrance of this trail. A
UXO warning sign is
not present, however.

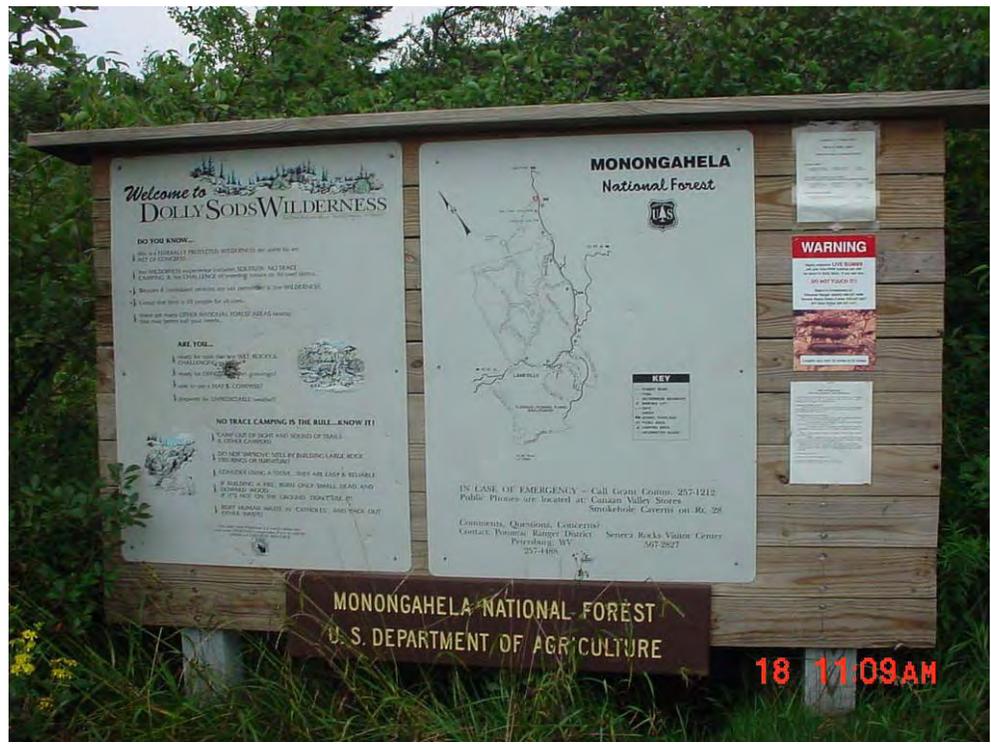
Photo Number:
5-Revisit

Description of Photo:
Blackbird Knob
trailhead sign.

Comments on Differences Between the Two Photos:
It appears as though a majority of the information presented at the trailhead sign has been replaced since the 2003/04 recurring review, but the UXO warning sign is still present.

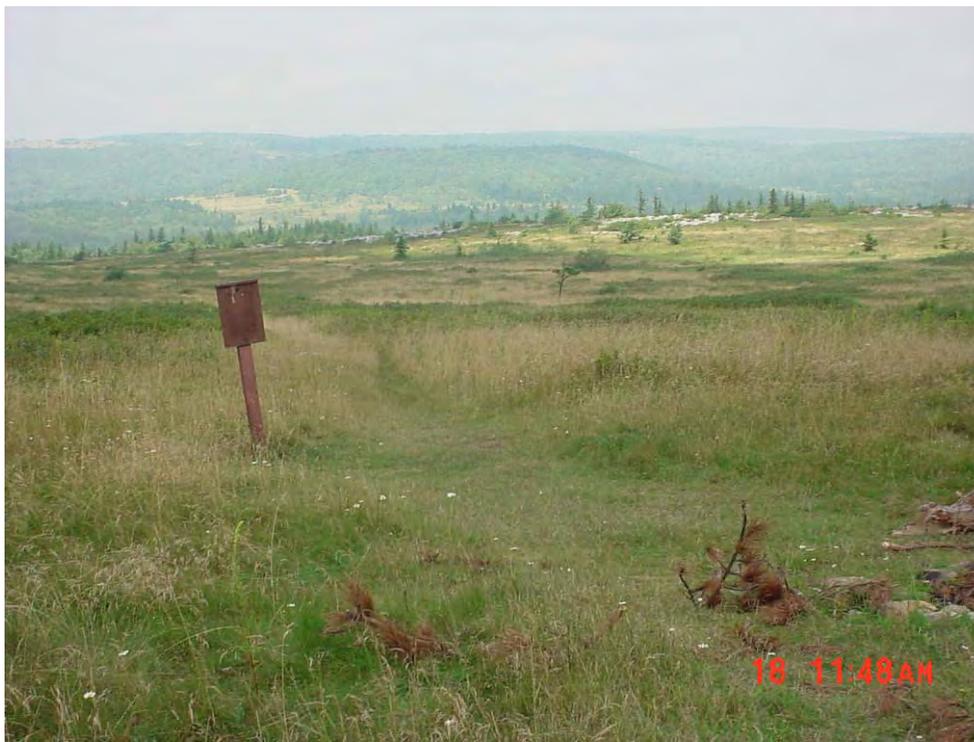
Photo Number:
6-Revisit

Description of Photo:
View of the Beaver Dam Trailhead. Note that the UXO warning sign had been previously removed from the post marking the entrance to this trail.

Comments on Differences Between the Two Photos:
Note that the trailhead sign had been replaced since the 2003/04 recurring review site visit. The UXO warning sign was present at the trailhead sign.

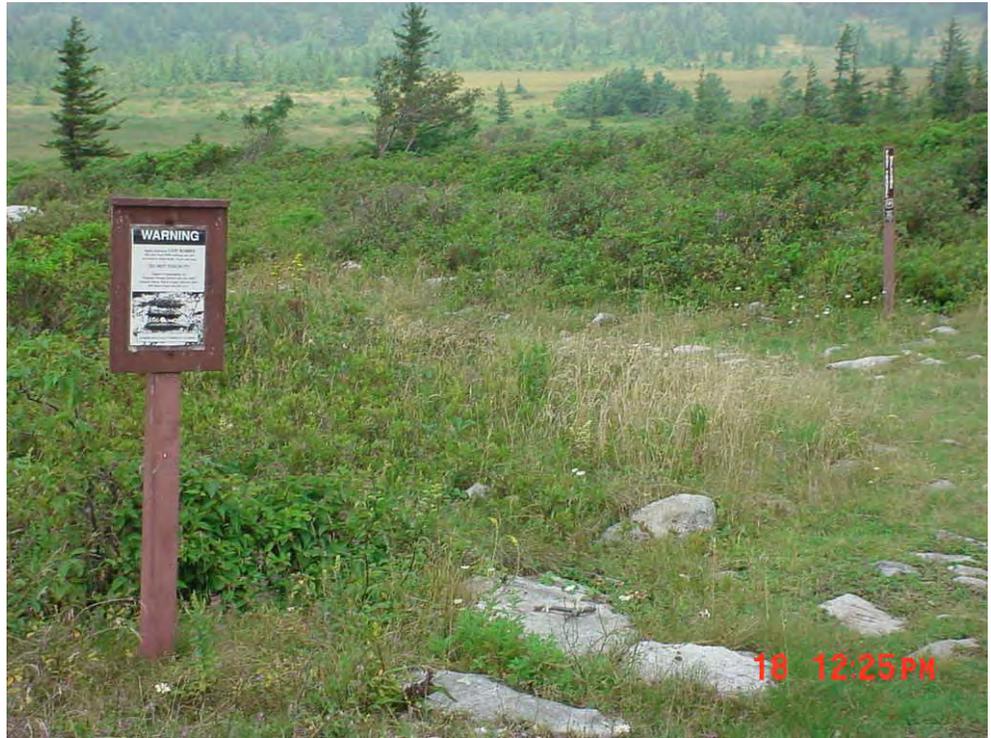
Photo Number:
7-Revisit

Description of Photo:
Bear Rocks Trailhead sign.

The trailhead sign
located at this location
has been replaced with a
new sign. The previous
UXO warning sign was
replaced with a new,
brighter UXO warning
sign.

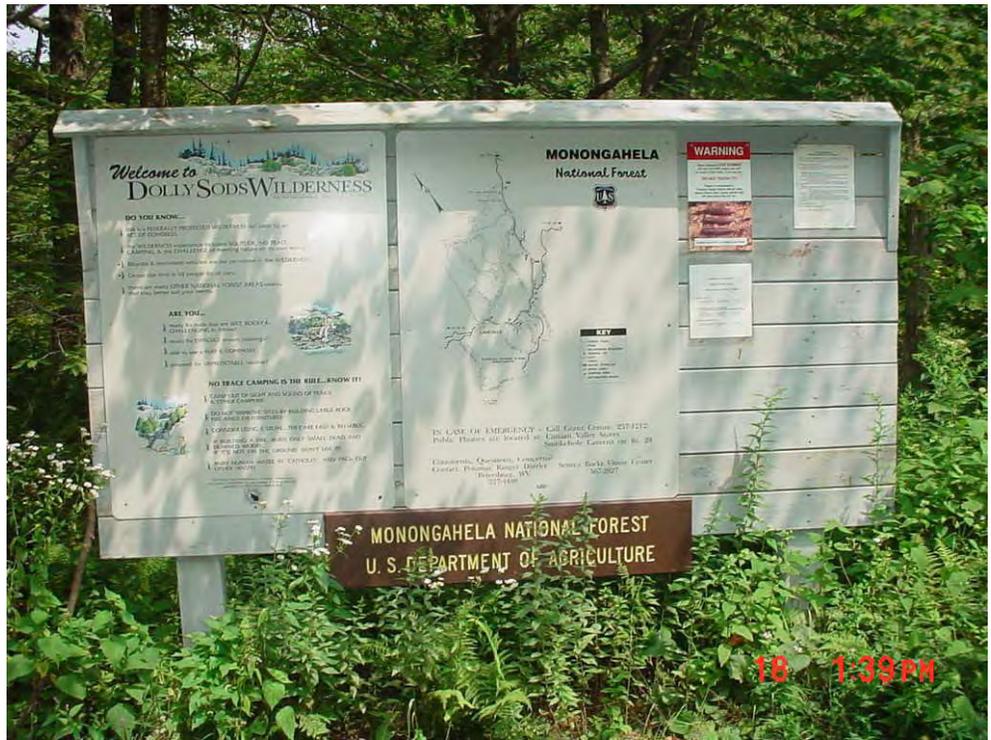
Photo Number:
8-Revisit

Description of Photo:
Wildlife Trail trailhead sign.

Comments on Differences Between the Two Photos:
It appears as though the information contained on this trailhead sign has been updated since the 2003/04 five-year recurring review. The UXO warning sign that was on the previous sign has been replaced.

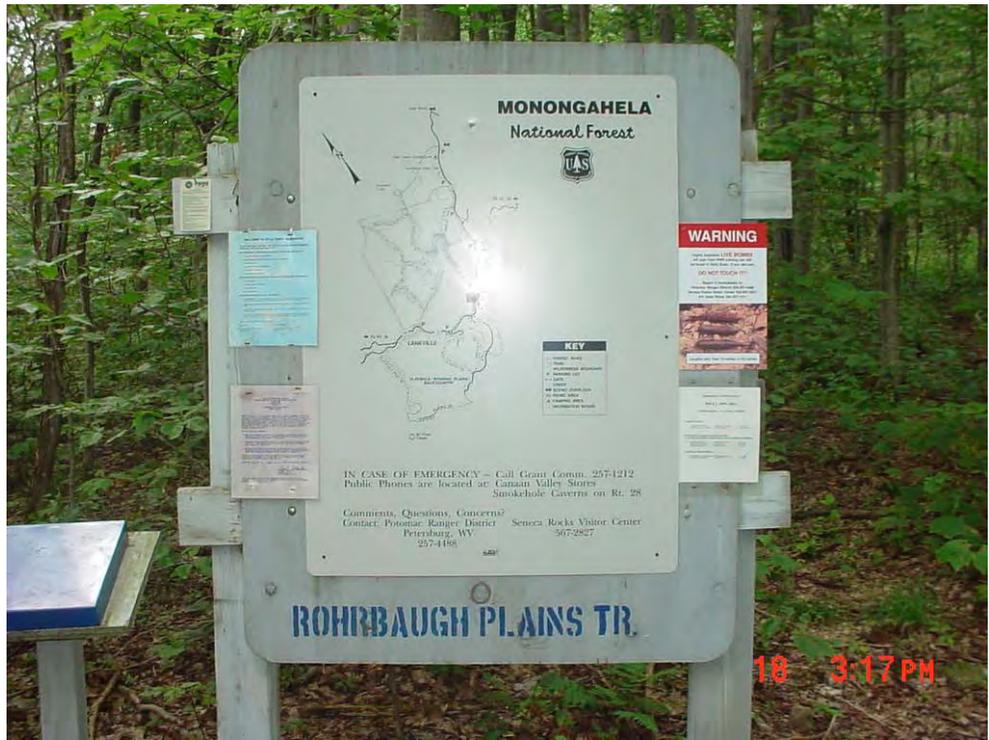
Photo Number:
10- Revisit

Description of Photo:
Trailhead sign located at
the entrance to the
Rohrbaugh Plains Trail.

Comments on
Differences Between the
Two Photos:
It appears as though the
sign and the information
on the sign, have been
replaced since the
2003/04 five-year
recurring review. Note
that a new UXO
warning sign has been
placed on the trailhead
sign.

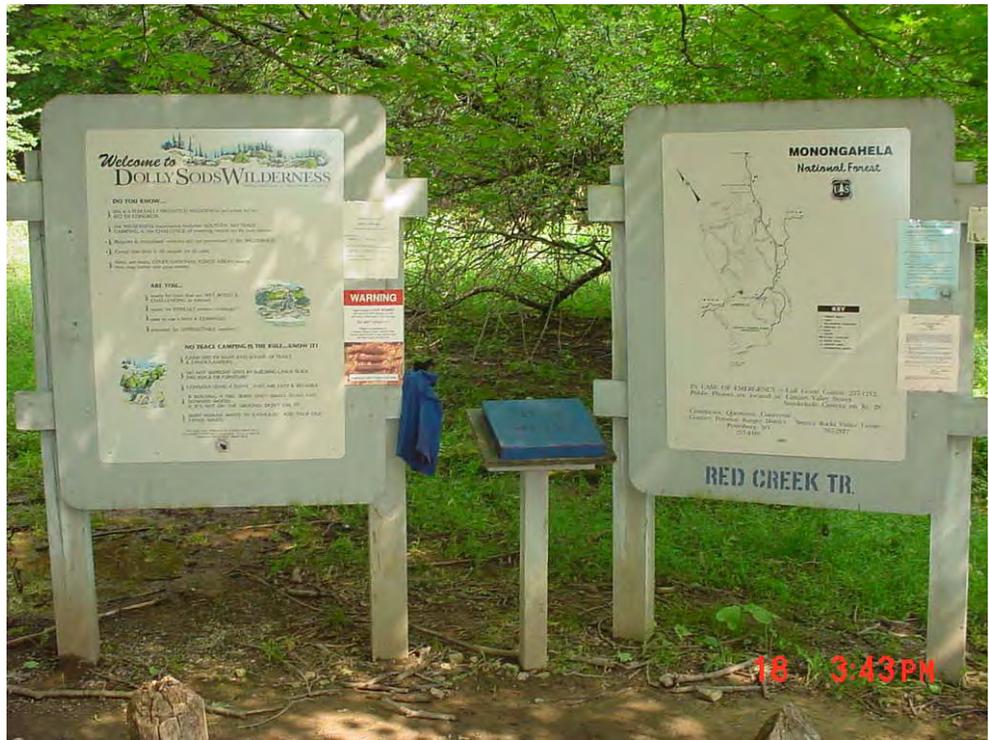
Photo Number:
11-Revisit

Description of Photo:
Red Creek trailhead sign.

Comments on Differences Between the Two Photos:
Note that the signs, as well as the information contained on the signs, have been revised since the 2003/04 five-year recurring review. Note that the UXO warning sign is present on this trailhead sign.

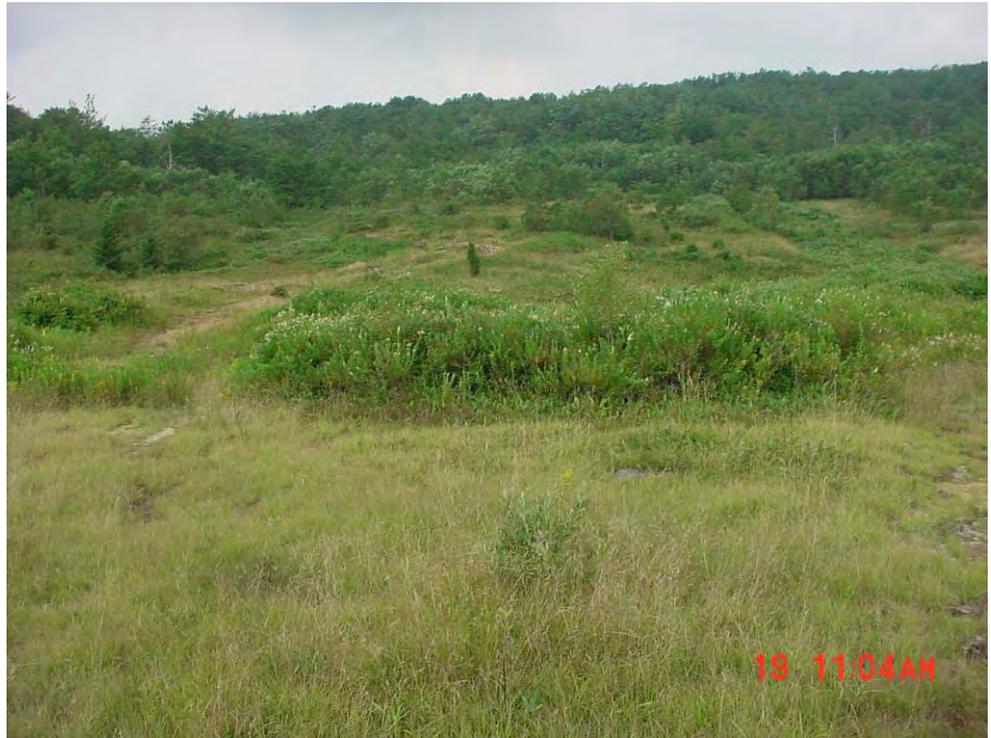
Photo Number:
12-Revisit

Description of Photo:
Intersection of Dobbin
Grade and Upper Red
Creek Trails. View
shows no noticeable
erosion evident and
abundant vegetation.

This view shows the
same area from a
slightly different angle.
Much as the previous
photo, there is minimal
erosion and abundant
vegetation noted in this
area.

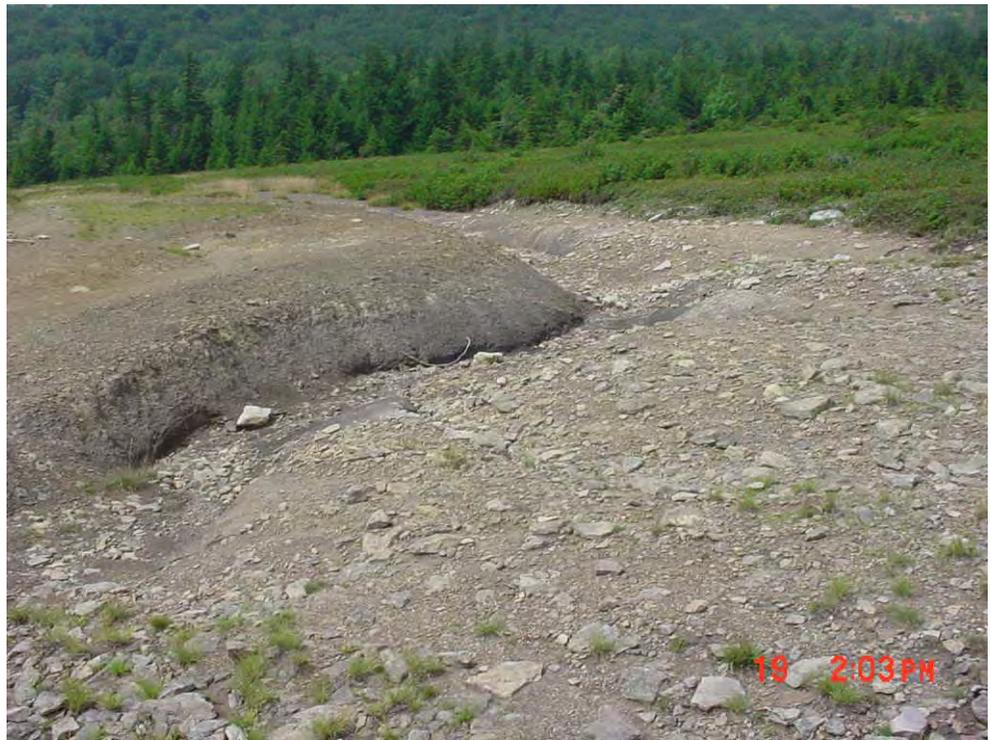
Photo Number:
14-Revisit

Description of Photo:
Isolated area of erosion.

Comments on
Differences Between the
Two Photos:
This photo clearly
shows the same area of
erosion. There is no
noticeable differences
between the two photos.

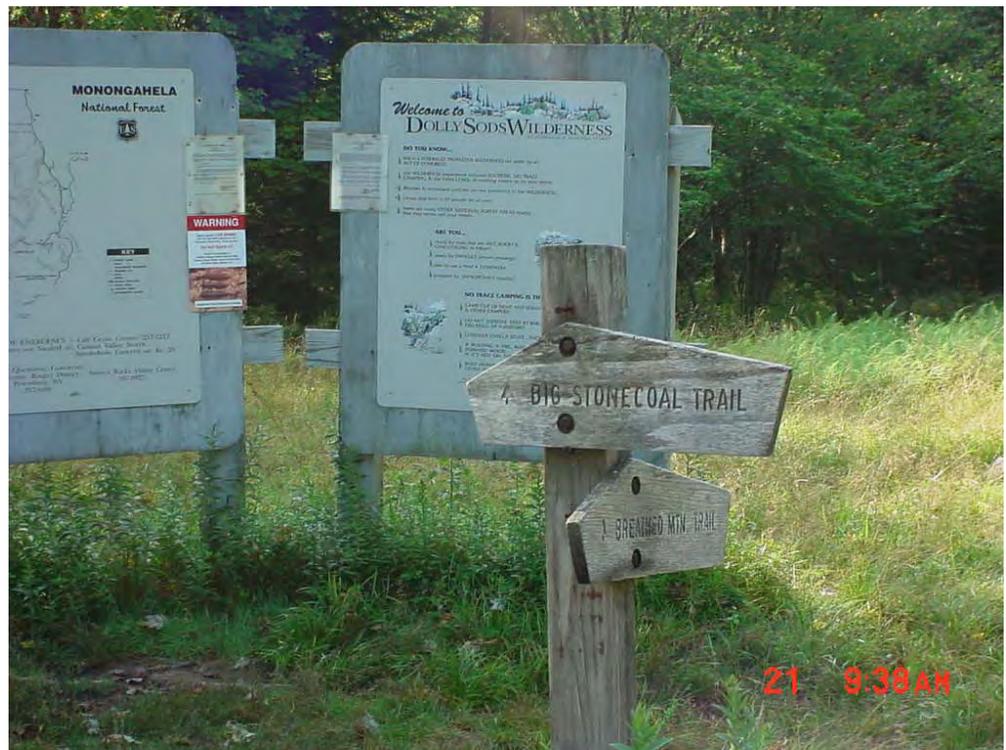
Photo Number:
15-Revisit

Description of Photo:
This photo shows the
information kiosk and
trailhead signs at the
intersection of Big
Stone Coal and
Breathed Mountain
Trails.

Comments on
Differences Between the
Two Photos:
The signs located at the
information kiosk and
trailhead markers appear
to have remained the
same since the initial
site visit. It was noted
to USFS officials at the
time that there were no
UXO Warning Signs
located at this position.

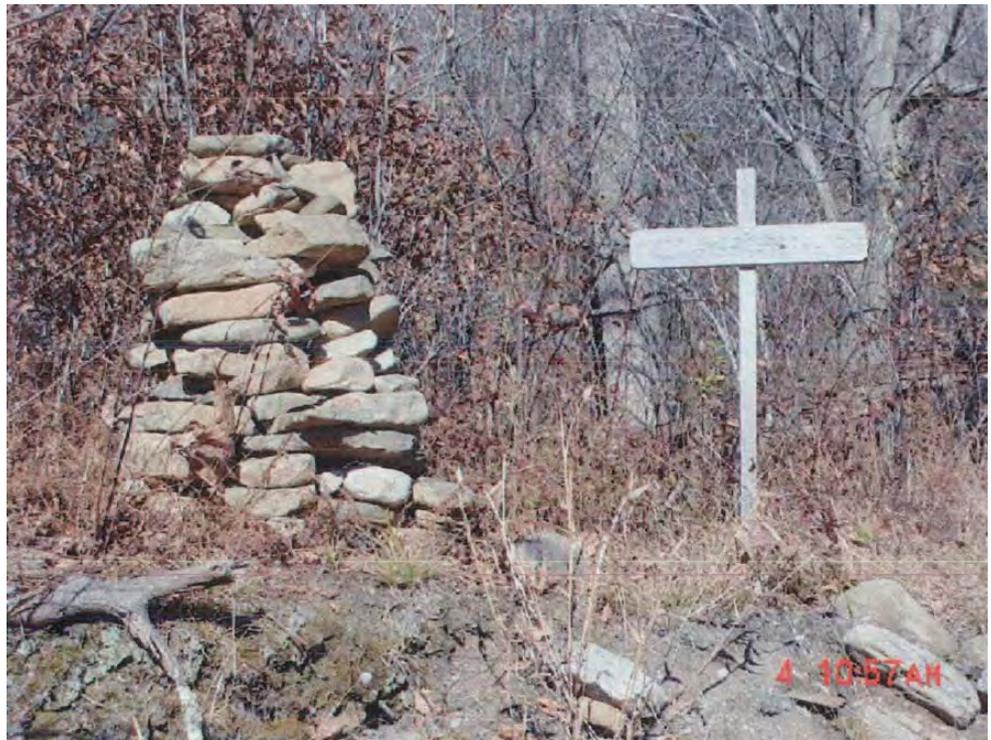
Photo Number:
22-Revisit

Description of Photo:
Photo of a trail marker
on Little Stone Coal
Trail near Red Creek.

Comments on
Differences Between the
Two Photos:
The stone structure
shown in the 2003 photo
(above) was not present,
replaced by a rock cairn.

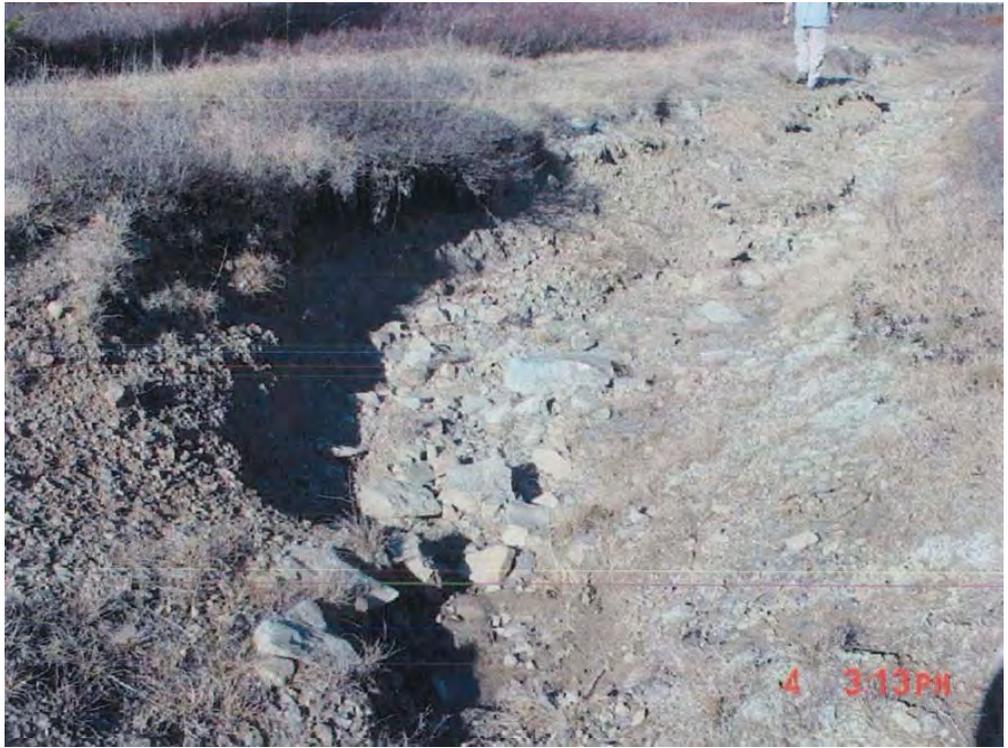
Photo Number:
24-Revisit

Description of Photo:
This photo shows a
close up view of the
erosion shown in the
previous photo.

Comments on
Differences Between the
Two Photos:
This photo shows the
same area as shown in
the 2003 photo above.
This view shows that
very little has changed
on the site in the past six
years, and that the site
has an abundance of
vegetation.
