Formerly Used Defense Sites Newsletter

Summer 2014 Edition

USACE HUNTINGTON DISTRICT COMPLETES SOIL REMEDIATION IN TNT AREA A AT THE FORMER PLUM BROOK ORDNANCE WORKS IN SANDUSKY, OHIO

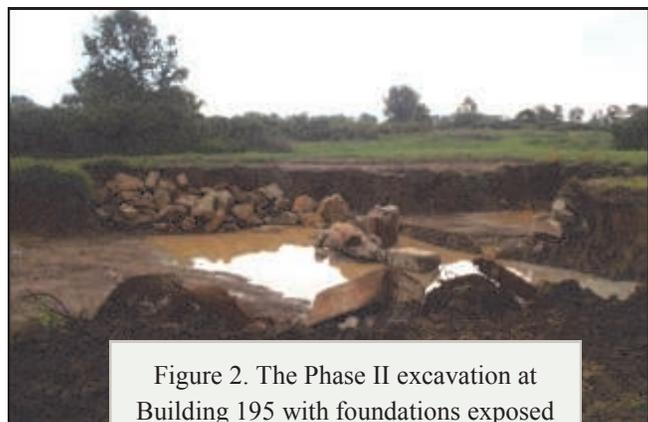
Figure 2. The Phase II excavation at Building 195 with foundations exposed

The US Army Corps of Engineers (USACE) Huntington District continues the environmental restoration at the former Plum Brook Ordnance Works (PBO) located in Sandusky, Ohio. The Formerly Used Defense Site (FUDS) Program environmental restoration conducted from January 2012 through May 2014 consisted of the Remedial Action-Construction (RA-C) effort in TNT Area A (TNT A). TNT A was one of three explosives manufacturing lines at PBO. Figure 1 depicts Building 195, which was one of the buildings in TNT A. The date of the picture is unknown but it was well after the cessation of manufacturing operations as evidenced by the heavy vegetation. Most of the manufacturing buildings have been demolished and the only evidence the buildings existed is their buried foundations (Figure 2).

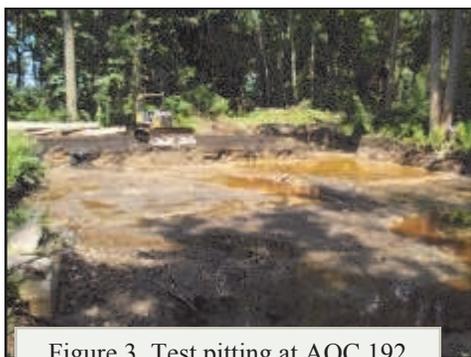
Figure 3. Test pitting at AOC 192

In May 2013, USACE initiated field efforts to excavate the remaining six AOCs in TNT A. Phase II efforts consisted of test pitting (Figure 3 and Figure 4), confirmation sampling, excavation of contaminated soil, backfilling the AOC with clean soil, soil characterization, transporting hazardous soil to the remediation pad, and transporting the non-hazardous soil to the Erie County Landfill for use as daily cover. 200-1e

Test pitting began by collecting samples from the walls and/or floors of each of the six AOCs where contaminant concentrations exceeded the Remedial Goals (RG), resulted in an exceedance of the risk criteria or contaminant “Not-to-Exceed (NTE)” concentrations. The test pits were placed at a location on the wall and/or floor that was “hot” and moved in an outward direction (or deeper if the hot spot was on the floor). Test pit samples were analyzed to determine if the contamination was below the RG, compliant with risk criteria and no NTE exceedances. Once the extent of the contamination was delineated, confirmation samples were collected and analyzed to “confirm” the extent of the contamination had been identified. With the contamination delineated, the extended areas of each open excavation were surveyed and staked, and the contaminated soil was excavated and stockpiled for characterization.

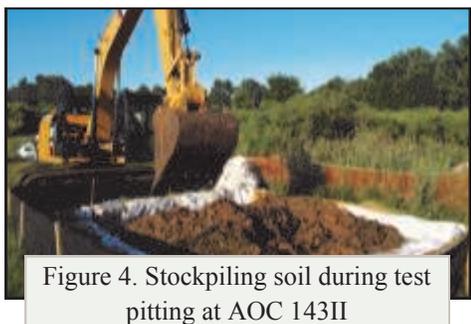
Figure 4. Stockpiling soil during test pitting at AOC 143II

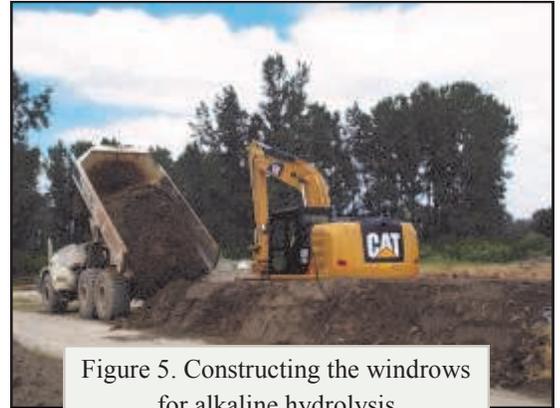
Figure 5. Constructing the windrows for alkaline hydrolysis

The Phase II stockpile soils were characterized to determine if the soil was non-hazardous or hazardous. The non-hazardous soil was transported to the Erie County Landfill for use as daily cover. The soil that was characteristically hazardous was transported (Figure 5) to the remediation pad to undergo alkaline hydrolysis remediation along with the hazardous soil from Phase I.

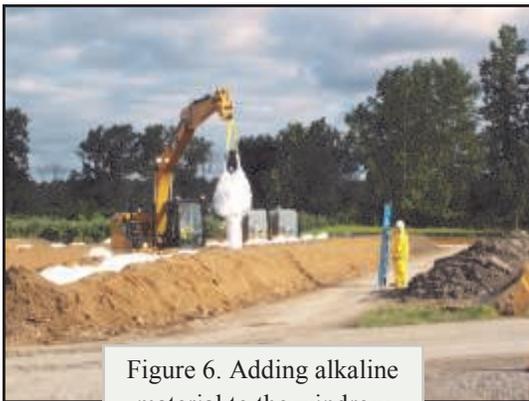
Figure 6. Adding alkaline material to the windrow

The alkaline hydrolysis process has been used at PBOW in remediating nitroaromatic-contaminated soil on past projects. During remediation of the TNT A soil, the alkaline hydrolysis (Figure 6) process reduced the nitroaromatics to levels where a portion of it could be placed back in the open excavation as backfill. Clean soil was purchased locally to complete backfilling each AOC.

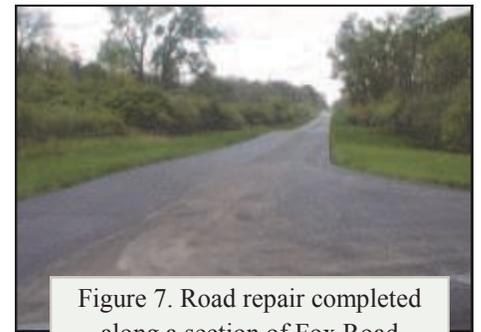
Figure 7. Road repair completed along a section of Fox Road

All of the field efforts for TNT A Phase II were completed by the end of the December 2013. This included backfilling all of the AOCs, restoring the remediation pad as well as planting native prairie grass in each of the 6 AOCs. Part of the restoration included repairing the roads impacted from the heavy equipment and trucks hauling soil to the landfill. Road repair (Figure 7) was delayed due to the weather conditions but it was completed before the end of the contract. The final report on the TNT Area A Remedial Action-Construction was completed in late May 2014. With the completion of the TNT Area A RA-C, the USACE has completed the soil remediation in all three manufacturing areas at PBOW.

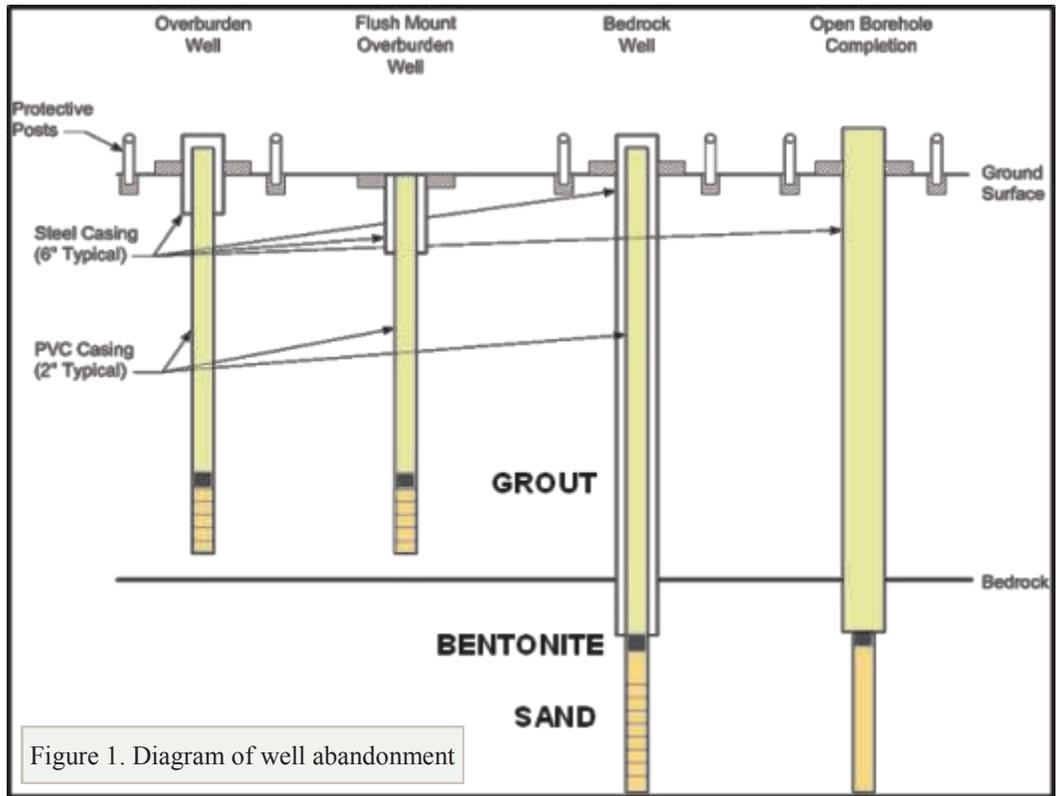
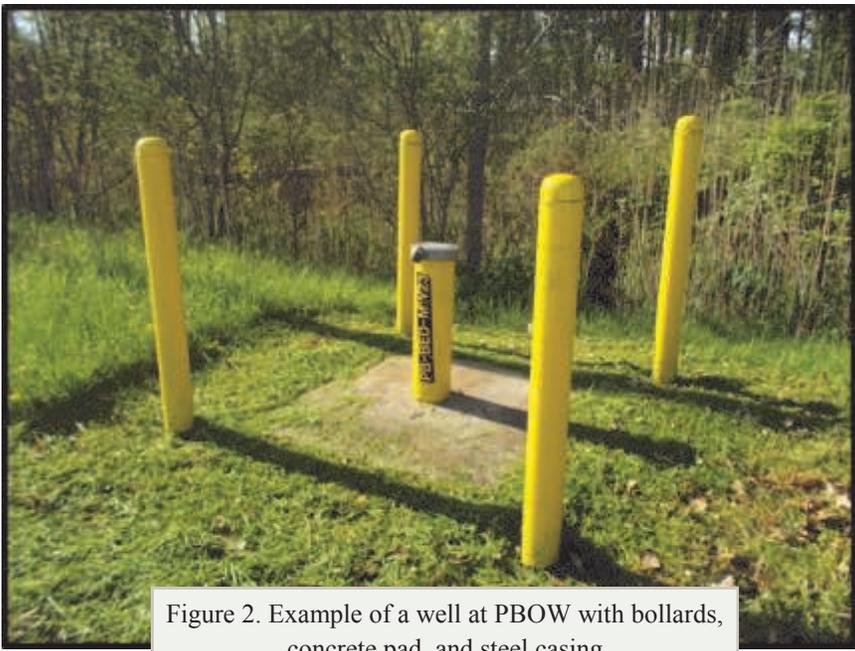
The USACE’s groundwater monitoring wells at the PBOW site includes bedrock wells to monitor the deep groundwater and overburden wells to monitor the shallow groundwater. Abandoning the bedrock wells in-place will consist of filling the casing with sand, and then a foot of bentonite (Figure 1) will be placed on top of the sand. Bentonite is a natural clay material that will swell with moisture and seal the well from the inside. Then each well will be topped off with grout to approximately four feet below the ground surface. Once the well is sealed, a crew will remove the bollards and pad (Figure 2), then excavate to 3-4 feet below ground surface, cut the casing and remove it from the well. All of

the overburden wells will be abandoned by removing the entire casing, simply by pulling them out. If the casing cannot be removed, they will be abandoned in-place, the same as the bedrock wells. The debris (concrete, well casings, bollards) generated from the well abandonment will be decontaminated and disposed off-site. The abandoned well locations will be restored by placing clean soil in the excavation, grading and planting grass. The work plans are currently being drafted and USACE is anticipating to begin the work in the early fall 2014.

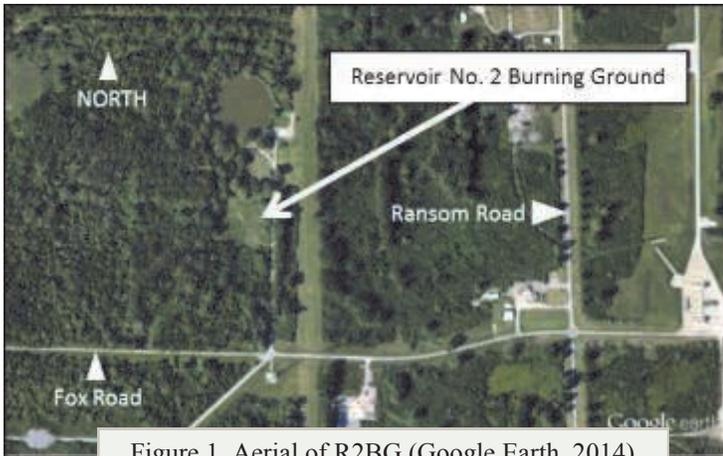
Figure 1. Aerial of R2BG (Google Earth, 2014)

In late June 2014, the US Army Corps of Engineers (USACE) awarded a contract for a Remedial Action-Construction (RA-C) project at the Reservoir No. 2 Burning Ground (R2BG) at the former Plum Brook Ordnance Works located in Sandusky, Ohio. R2BG is located in the northwestern portion of PBOW and is located west of Ransom Road and is bounded by Fox Road on the south. The site was used during demolition activities as a burning ground. There are no buildings or other man-made features at R2BG, only trees and grass on the approximate 4-acre site as depicted in Figure 1.

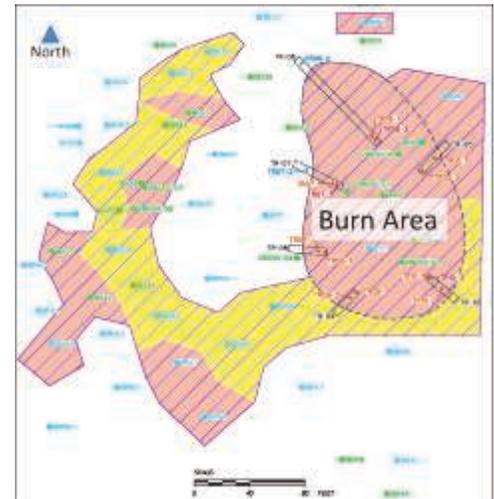
Figure 2. R2BG excavation area

The R2BG site consists of an area designated as the “burn area” (Figure 2) which was the primary area where

burning took place. The burn area was identified by a layer of burned material about 1 foot thick and approximately 1 foot below the surface. The burn area is approximately 0.4 acres. The area adjacent to the burn area was also impacted by the burning activities most likely from moving the burned materials away from the burn pile. The total volume of soil to be excavated is 7,395 cubic yards. The burn area will be excavated to a depth of 8 feet and the area outside the burn area will be excavated to a depth of 2 feet.

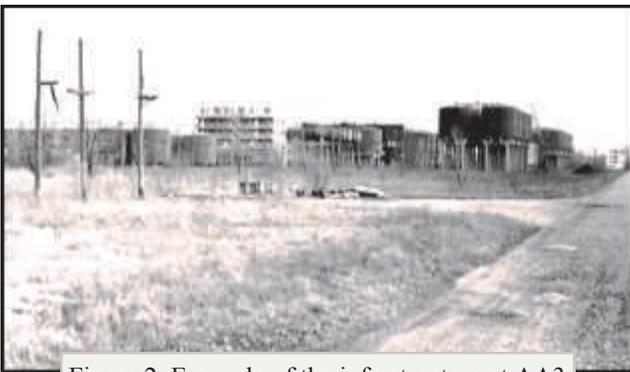
Figure 2. Example of the infrastructure at AA3

process buildings, 46 above-ground storage tanks and a rail line (Figure 2).

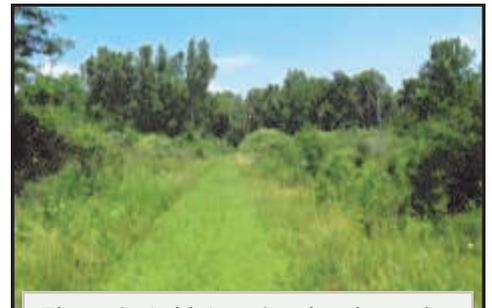
Figure 3. Acid Area 2 as it exists today

Today, the acid areas are quiet, peaceful and overgrown with vegetation (Figures 3 and 4), including mature trees and an abundance of wicked, thorny trees and multiflora rose. The dense coverage provides safe shelter for small mammals seeking refuge from the local birds of prey.

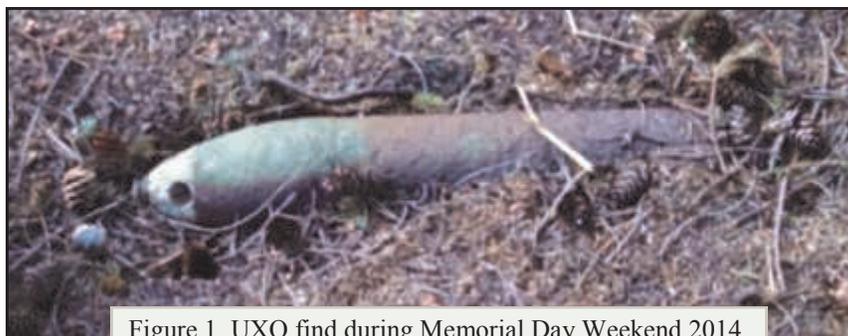
Figure 1. UXO find during Memorial Day Weekend 2014. Identified as a 4.2" mortar, white phosphorus, M2A1

Corps acts quickly to remove mortar found along Dolly Sods trails. Over Memorial Day Weekend 2014, an Unexploded Ordnance (UXO)—a 4.2” mortar containing white phosphorous—was found in the Dolly Sods Wilderness Area (DSWA) of West Virginia by Boy Scouts who were backpacking and camping in the area (Figure 1).

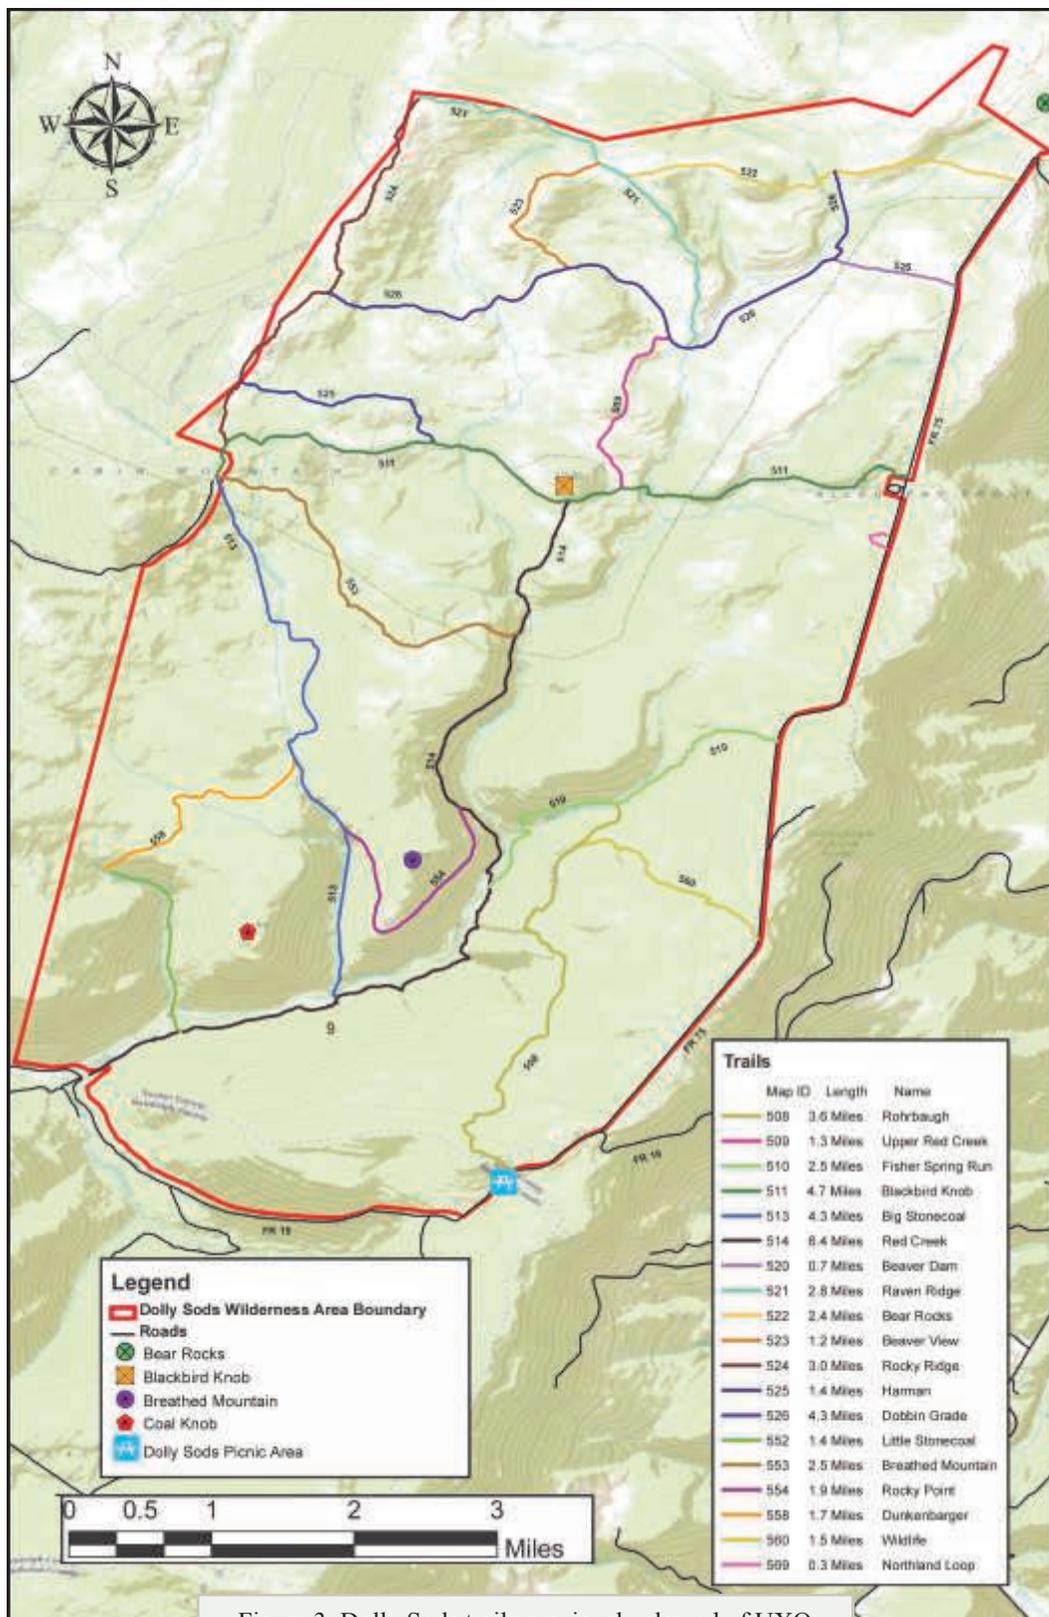
Figure 3. Dolly Sods trails previously cleared of UXO

Historically, UXO removal was performed at WVMA immediately after WWII and again in 1997-1998. The 1997-1998 removal focused on the existing trails and campsites of DSWA (see Figure 3 for current map of trails cleared). Subsequently, warning signs were posted at the trailheads to warn the public of UXO dangers outside the cleared areas. Outdoor activities at DSWA outside of the cleared areas include an increased level of risk of encountering UXO.

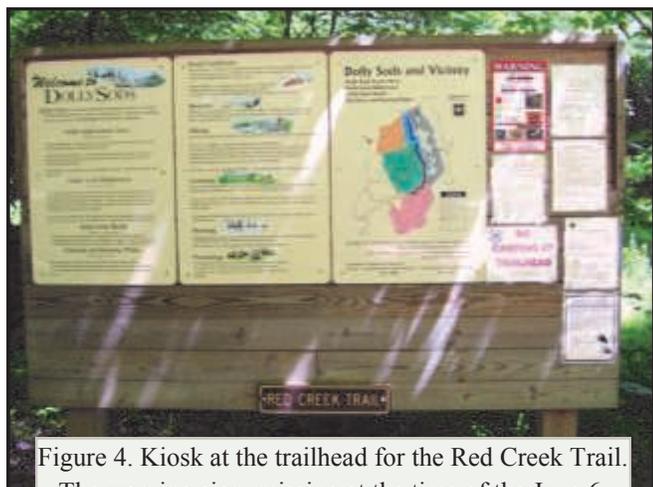
Figure 4. Kiosk at the trailhead for the Red Creek Trail. The warning sign, missing at the time of the June 6, 2014 inspection, was replaced with a duplicate sign

Also, semi-annual inspections of the warnings signs posted at the heads of the cleared trails and at the cleared campsites are made to help ensure the public is aware of UXO dangers that may exist in areas of Dolly Sods not cleared of UXO. Figures 4-5 are photos from the June 6, 2014 trailhead inspection .
