**Powerhouse No. 2 Ash Pits  
Site Characterization Report Addendum for Coal Yard No. 2  
Former Plum Brook Ordnance Works, Sandusky, Ohio**

**Shaw Environmental and Infrastructure, Inc.  
312 Directors Drive  
Knoxville, Tennessee 37923**

**September 2012**

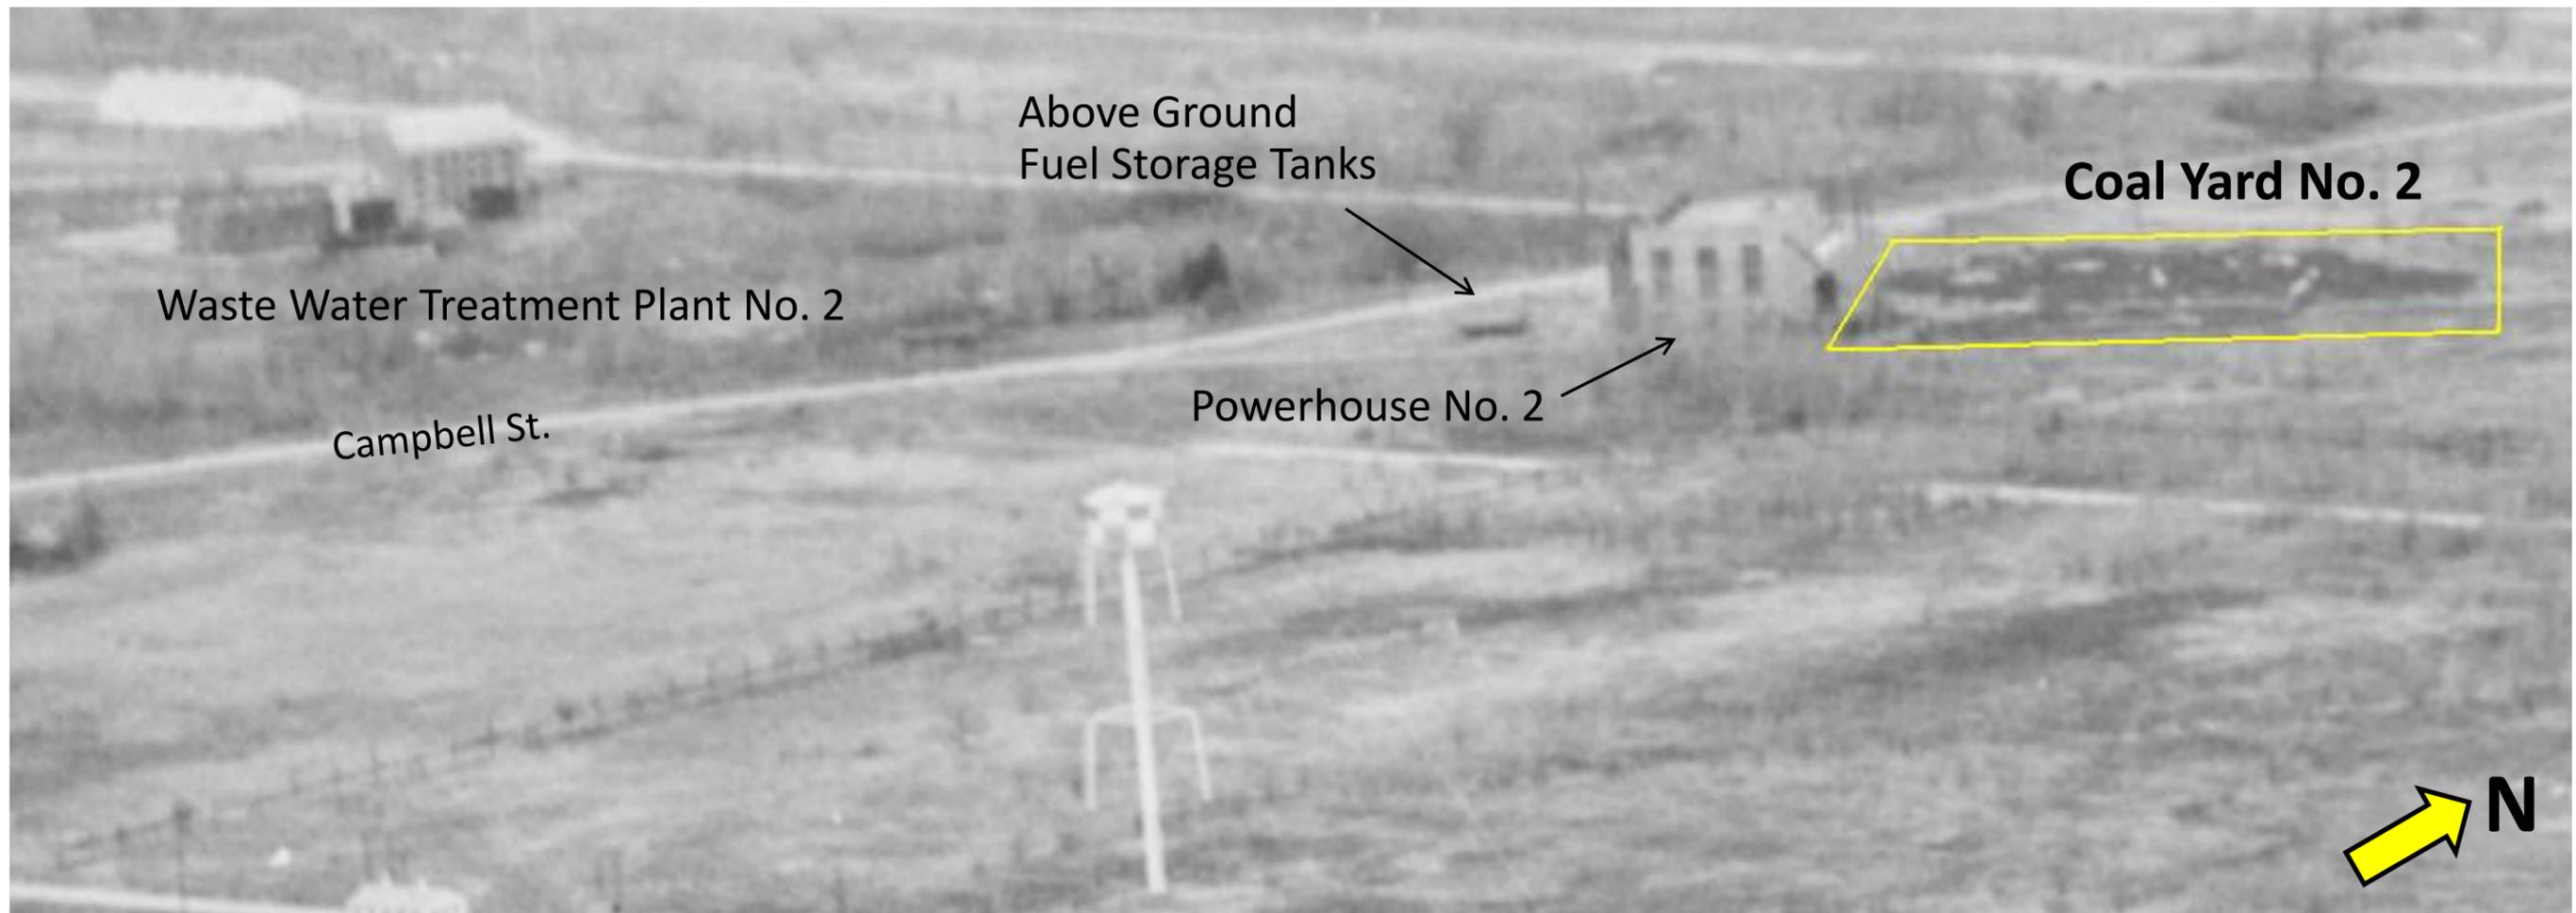
Figure 1-3  
Coal Yard No. 2, Circa 1958 Photo  
(View is to the Northwest)

Coal Yard No. 2 is located immediately to the northeast of Powerhouse No. 2. The historical former coal yard is estimated to have been approximately 200-feet wide by 290-feet in length or nearly 1.4 acres. The area has recently been filled and graded. The site was observed to be covered with bare soil during a site visit on September 1, 2011, but shoots of plants were observed to be emerging from the ground, suggesting the site will naturally re-vegetate in the near future. Recent demolition of the former Powerhouse No. 2 building by NASA resulted in some disturbance of surface soil and vegetation, primarily in areas outside of the footprint of the former coal yard. Minor amounts of coal were observed on the ground surface in isolated areas during previous site walks. Figure 1-3 shows a historical photograph of the coal yard along with the associated powerhouse.

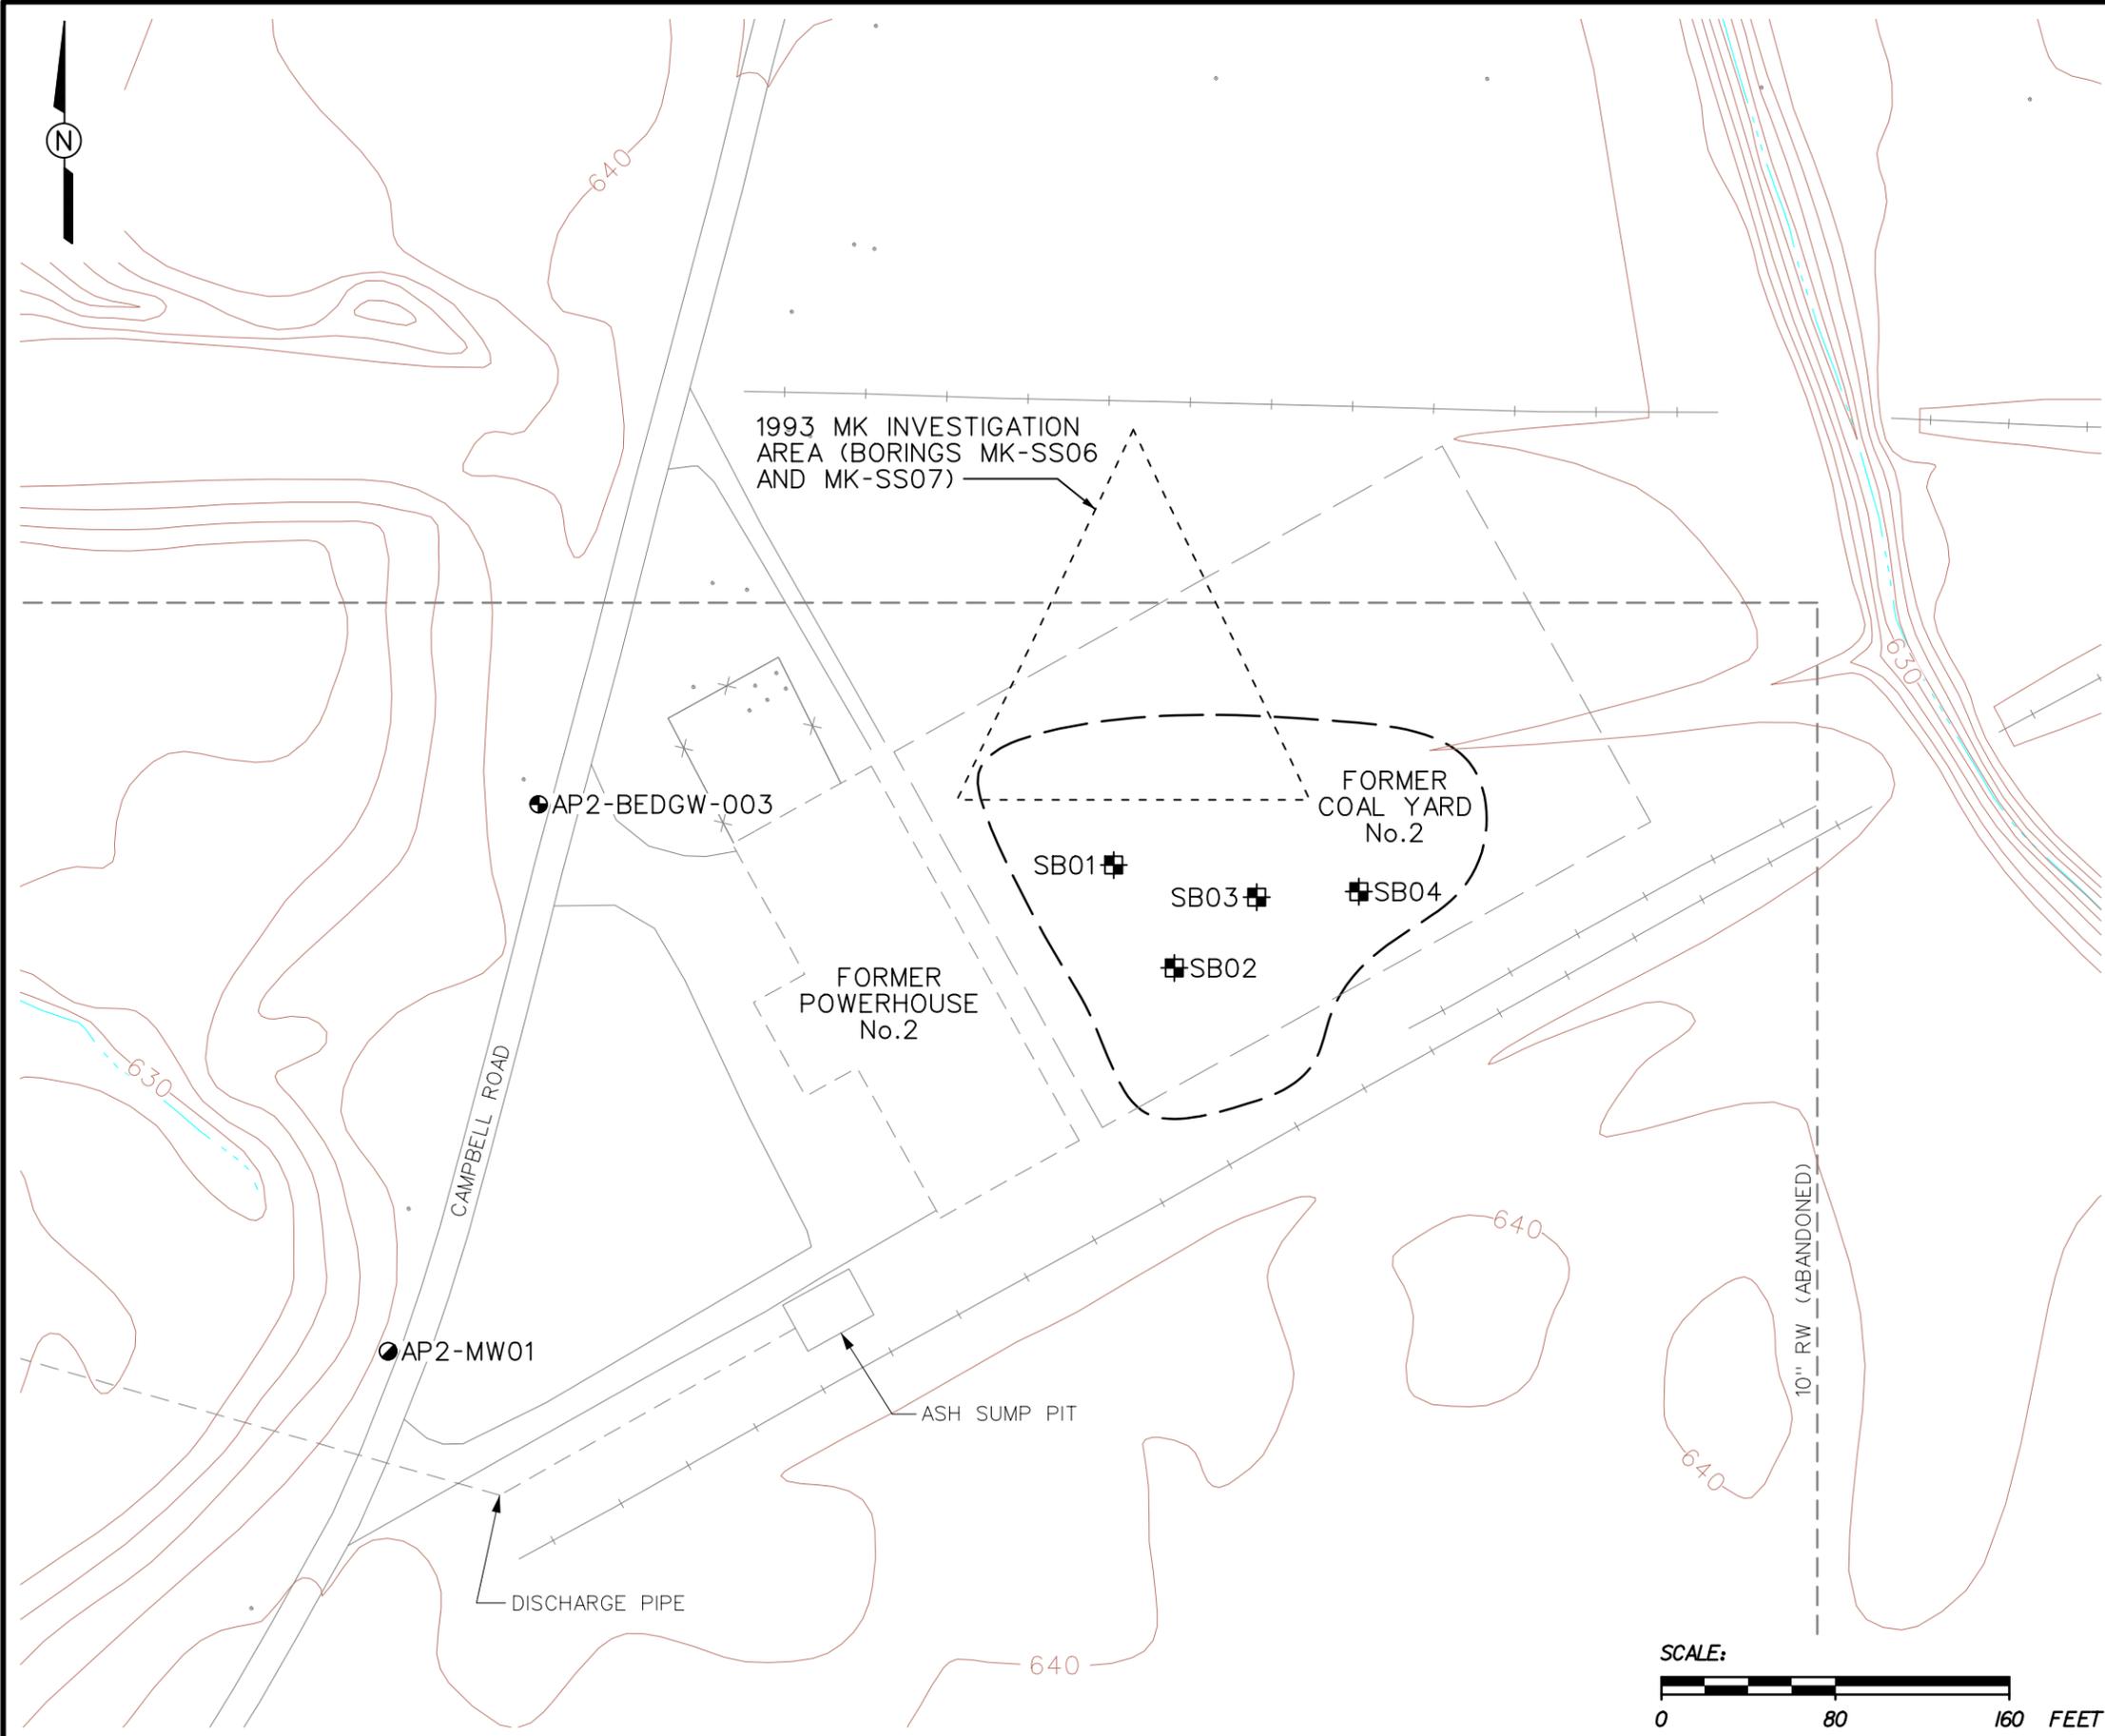
and inorganics. Table 1-1 presents historical analytical results and Figure 1-4 shows 1993 MK investigation area. The locations are approximate because the soil borings were not surveyed. From the SI report, the soil sample collection area was said to “exhibit no visual limits” and was estimated to be less than 3 acres in size. It also mentioned that the soil samples were collected on the northeast side of the building in an area of tall grass, and in addition to being a burning ground, based on small piles of coal, the area must have also been used as a coal storage area.

As noted in Section 1.5, Coal Yard No. 2 is located immediately adjacent to (northeast) of Powerhouse No. 2. Figure 1-4 shows the specific site location and general site features with ground surface topography. Descriptions and information regarding the local geography, topography, surface drainage, regional and local geology and hydrogeology characteristics, and precipitation influence effects on local water levels has been prepared and is included in the final Powerhouse No. 2 Ash Pits SCR (Shaw, 2010). The following sections describe the current site conditions for the Coal Yard No. 2 relative to this investigation.

Prior to soil boring drilling, excavation of the upper foot of surface soil was removed with a pickaxe throughout the former coal yard area to determine optimal placement for the soil borings. Removal of the surface soil was used to determine both the boundary of the former coal yard and the thicknesses of any remaining coal. From results, soil boring locations were chosen based on the interpreted extent of the former coal yard. Four soil borings (CY2-SB01, CY2-SB02, CY2-SB03, and CY2-SB04) were drilled at Coal Yard No. 2 using either a 2-inch or 3-inch stainless-steel hand auger. Soil collected from a sample interval was transferred to a new, resealable storage bag and thoroughly homogenized, and the sample bottles filled. All hand drilling activities were conducted by Shaw personnel on October 26 and 27, 2011. Figure 1-4 shows the location of the soil borings.

As noted in the Powerhouse 2 SCR (Shaw, 2010), fill sand was used at the close of PBOW and during remediation tasks to cover concrete foundations, demolition scars, and promote a natural landscape appearance. At Coal Yard No. 2, no fill sand was encountered in any of the four soil borings drilled for this investigation. The ground surface at three of the four soil borings was covered with a mixture of coal, silt, and sand to a depth of approximately 0.5 foot. A thin (0.2 foot) coal layer was encountered near the surface of the fourth boring (CY2-SB04) at a depth of 0.5 foot. The surface material at this location consisted of clay. Figure 1-4 shows a Coal Yard No. 2 site map with soil boring locations.

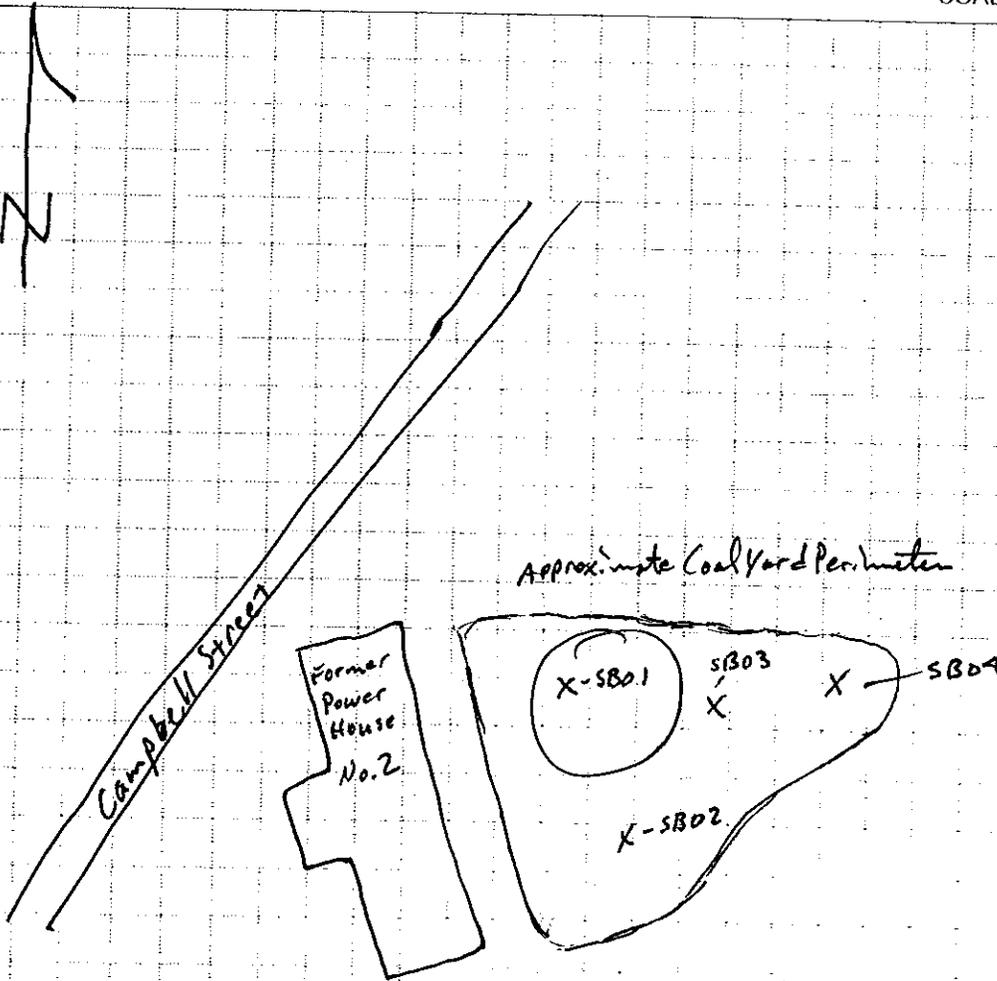
HOLE NO. *CY2-SB01*

Elev (ft)	Depth (ft) bgs	Description of Materials	USCS	Field Screening Results (ppm)	Geotech. Sample or Core Des. No.	Analytical Sample No.	Recovery (ft)	Remarks
		<b>Coal</b>						
	0.5'							
	1	<b>Yellowish brown (10yR5/6) silt with clay, moist, medium stiff.</b>	<b>ML</b>		<b>0940</b>	<b>0.5-1.0'</b> <b>CY0015</b> <b>CY0016</b>		<b>CY0017</b>
	2							
	3							
	4				<b>0955</b>	<b>3.0-5.0</b> <b>CY0018</b>		
	5	<b>- wet</b>						
	6							
	7							
	7.5'							
	8	<b>Gray (10yR5/1) silt with clay, wet, medium stiff.</b>	<b>ML</b>			<b>8.0-10.0</b> <b>CY0019</b>		
	9				<b>1020</b>			
	10	<b>Total Depth = 10 ft</b>

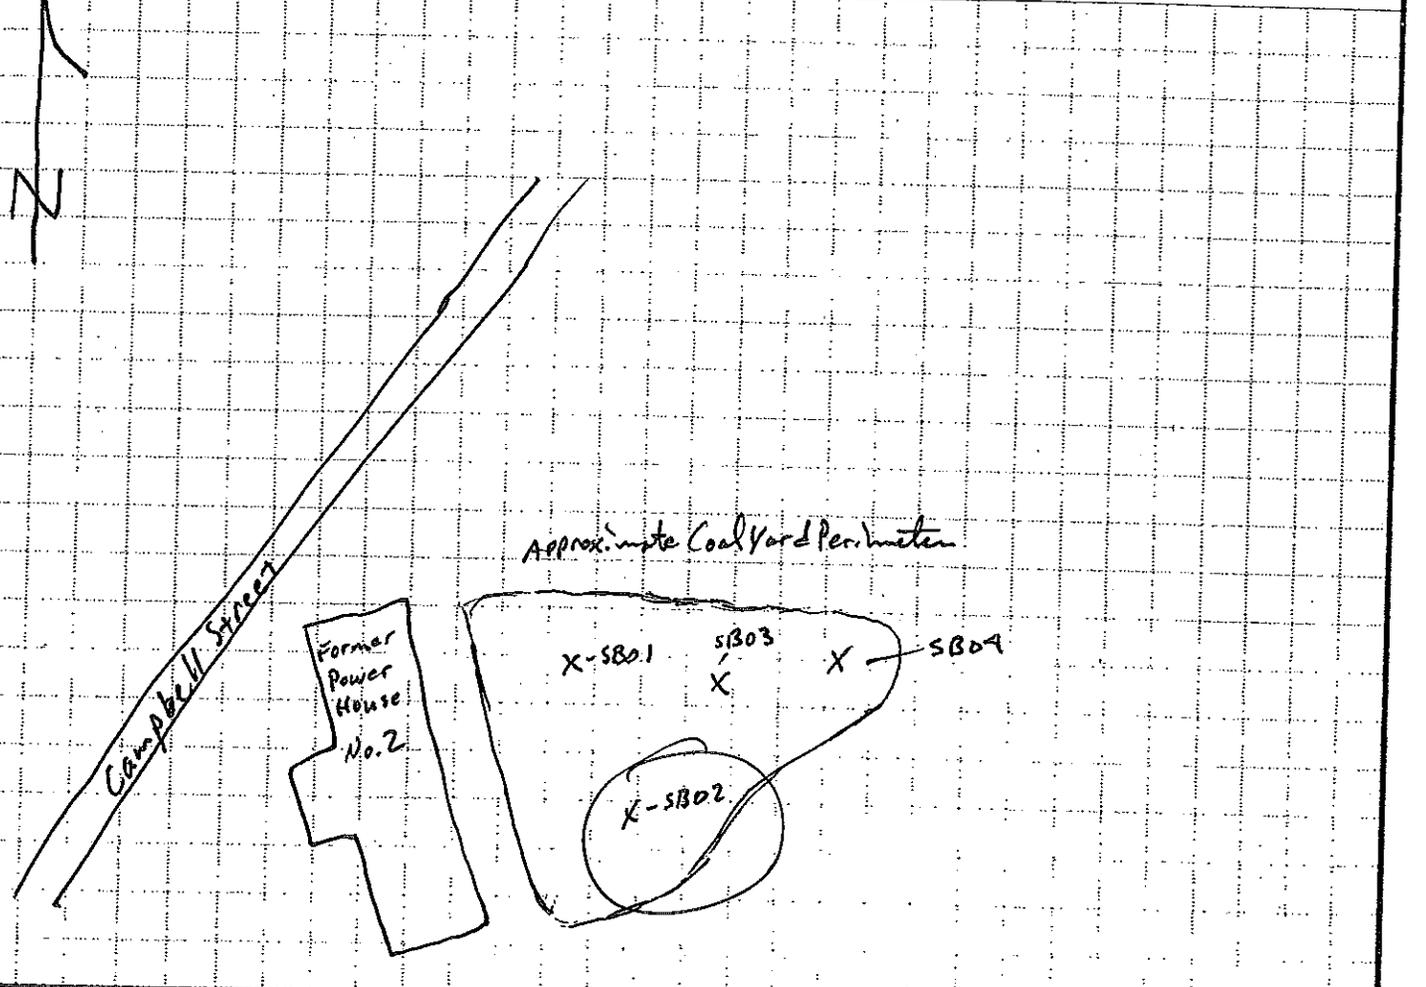
PROJECT PBOW HOLE NO. CY2-SB02

elev (ft)	Depth (ft) bgs	Description of Materials	USCS	Field Screening Results (ppm)	Geotech. Sample or Core Descr. No.	Analytical Sample No.	Recovery (ft)	Remarks
		Coal			7. line			
	0.5'							
	1	Yellowish brown (104R5/6) silt with clay, moist, medium stiff.	ML		0830	0.5'-1.0' CY0020		
	2							
	3							
	4				0850	3.0-5.0' CY0021		
	5	- wet						
	6							
	7							
	8							
	8'							
	9	Gray (104R5/1) silt with clay, wet, medium stiff.			0915	8.0-10.0' CY0022 CY0023 CY0024		
	10	Total Depth = 10 ft

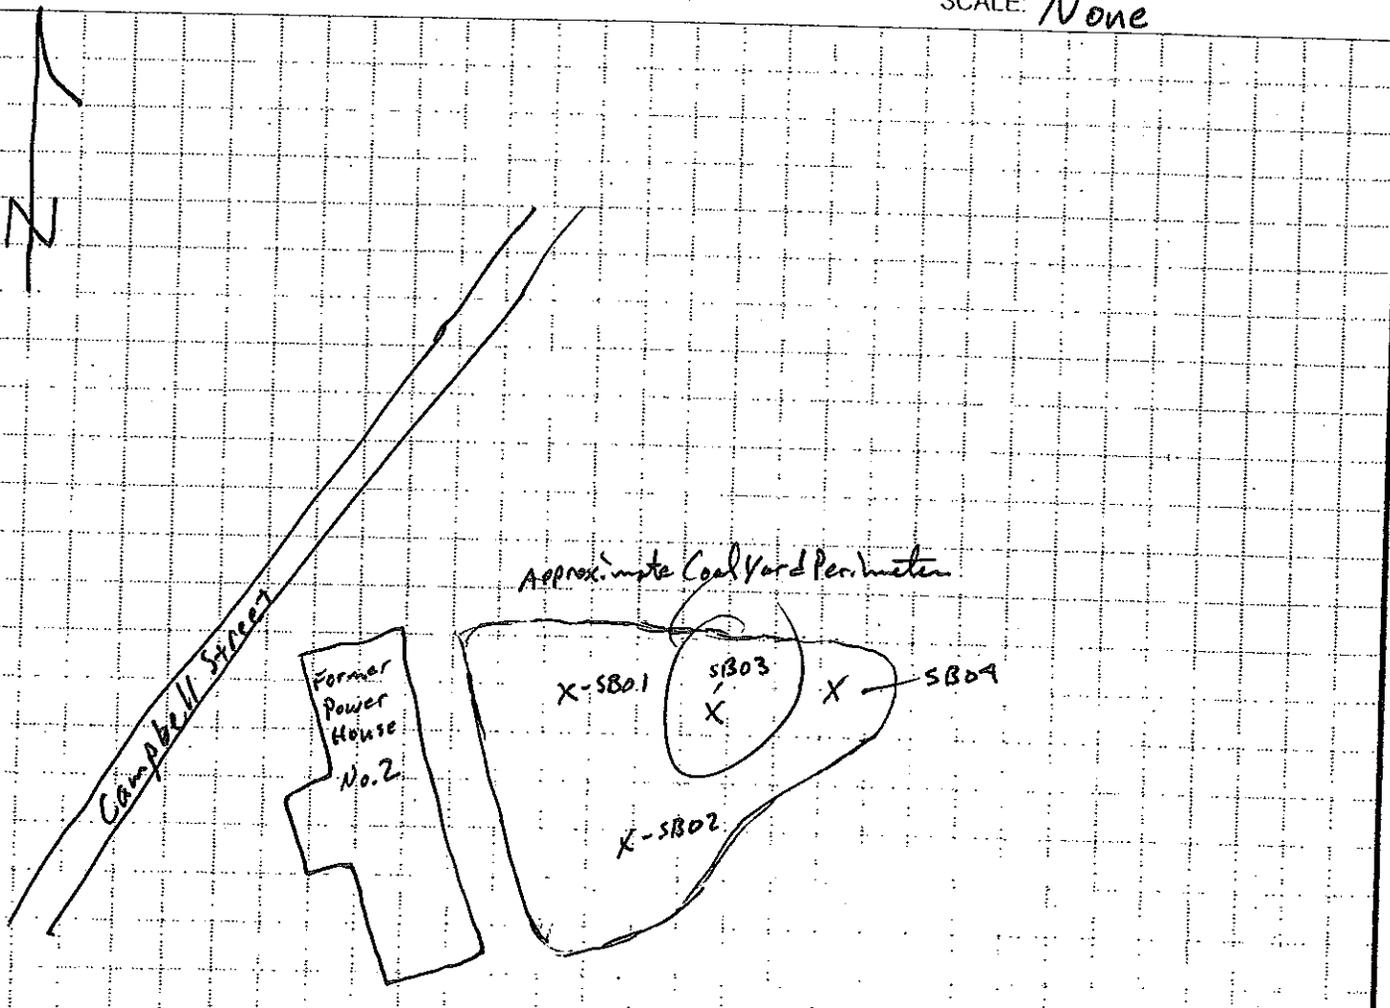
HOLE NO. **CY2-SB03**

Elev (ft)	Depth (ft) bgs	Description of Materials	USCS	Field Screening Results (ppm)	Benthic Sample or Core Box No.	Analytical Sample No.	Recovery (ft)	Remarks
		Coal			Time			
	0.5'							
	1	Yellowish brown (10YR 5/6) silt with clay, moist, med. stiff.	ML		1540	0.5'-1.0' CY0025		
	2							
	3							
	4				1555	3.0-5.0 CY0026		
	5	- wet						
	6							
	7							
	8							
	8'							
	9	Gray (10YR 5/1) silt with clay, moist, medium stiff.			1615	8.0'-10.0' CY0027		
	10	Total Depth = 10 Ft

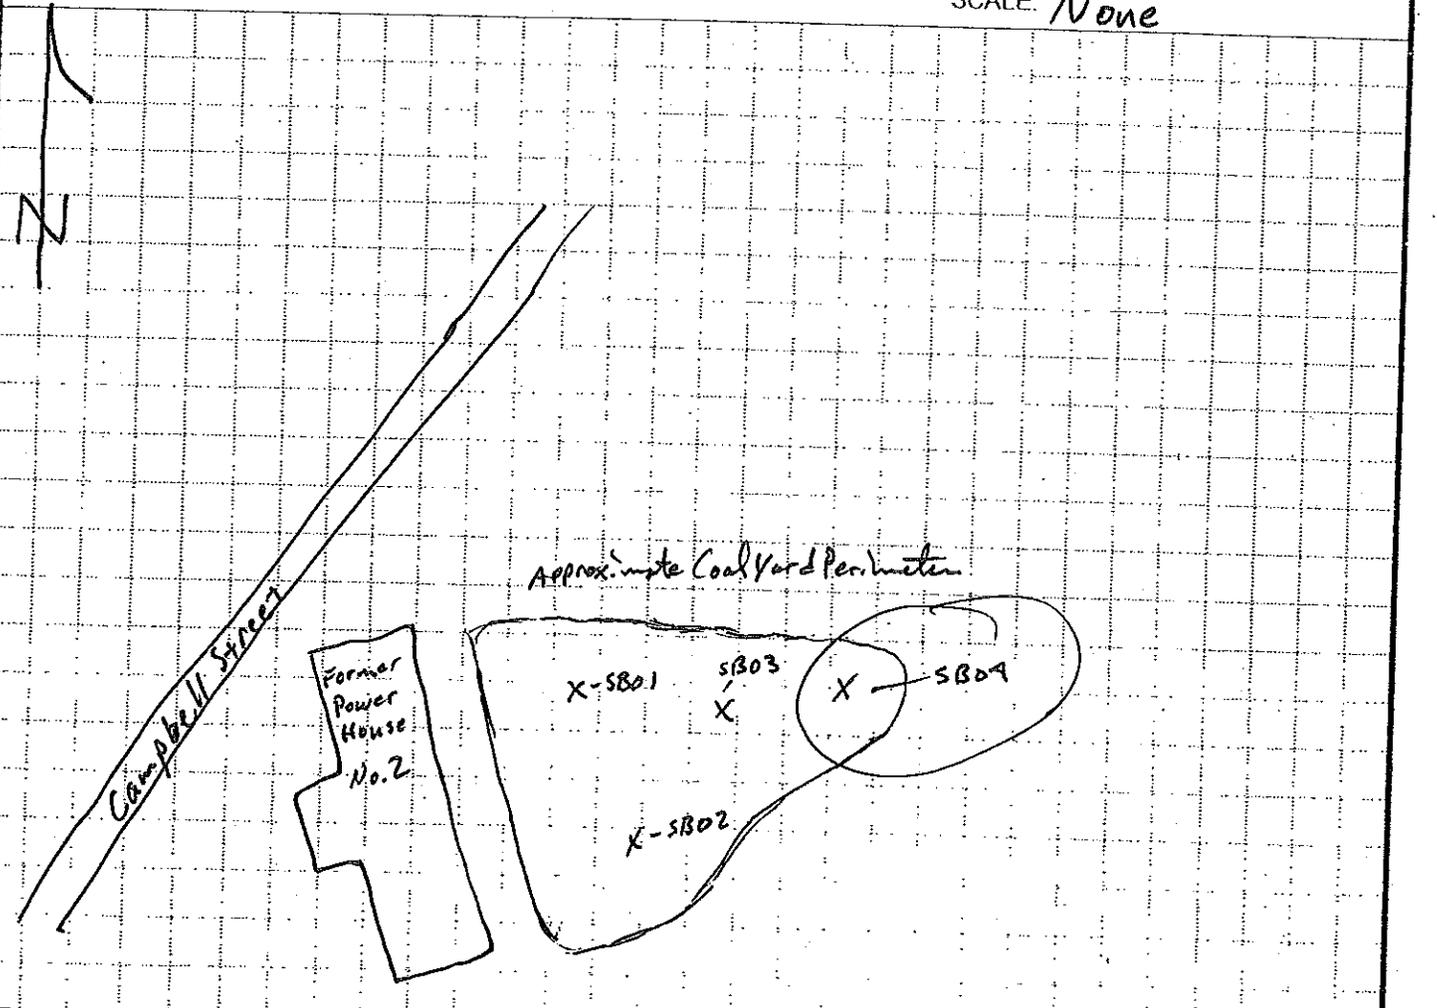
PROJECT **PBOW** HOLE NO. **CYZ-SB04**

Elev (ft)	Depth (ft) bgs	Description of Materials	USCS	Field Screening Results (ppm)	Geotech. Sample or Core Box No.	Analytical Sample No.	Recovery (ft)	Remarks
		Dark gray (10YR4/1) clay with silt, moist, medium stiff. - 0.5 - 0.7 - coal seam	CL		1410	0.0-1.0' CY0028		
	1	Yellowish brown (10YR5/6) silt with clay, moist, medium stiff.	ML					
	2							
	3							
	4				1430	3.0-5.0' CY0029		
	5							
	6	Grayish brown (10YR5/2) clay with silt, <del>trace sand, wet</del> , medium stiff.	CL					
	7							
	8	Gray (10YR5/1) clay with silt, trace sand, wet, medium stiff.			1450	8.0-10.0' CY0030		
	9							
	10	Total Depth = 10 ft
